COMMONWEALTH OF KENTUCKY
BEFORE THE PUBLIC SERVICE COMMISSION

APPLICATION OF LOUISVILLE GAS AND ELECTRIC)
COMPANY FOR AN ADJUSTMENT OF ITS) CASE NO.
ELECTRIC AND GAS RATES) 2014-00372

SUPPLEMENTAL RESPONSE OF
LOUISVILLE GAS AND ELECTRIC COMPANY
TO
THE FIRST SET OF DATA REQUESTS OF
KENTUCKY INDUSTRIAL UTILITY CUSTOMERS, INC.
DATED JANUARY 8, 2015

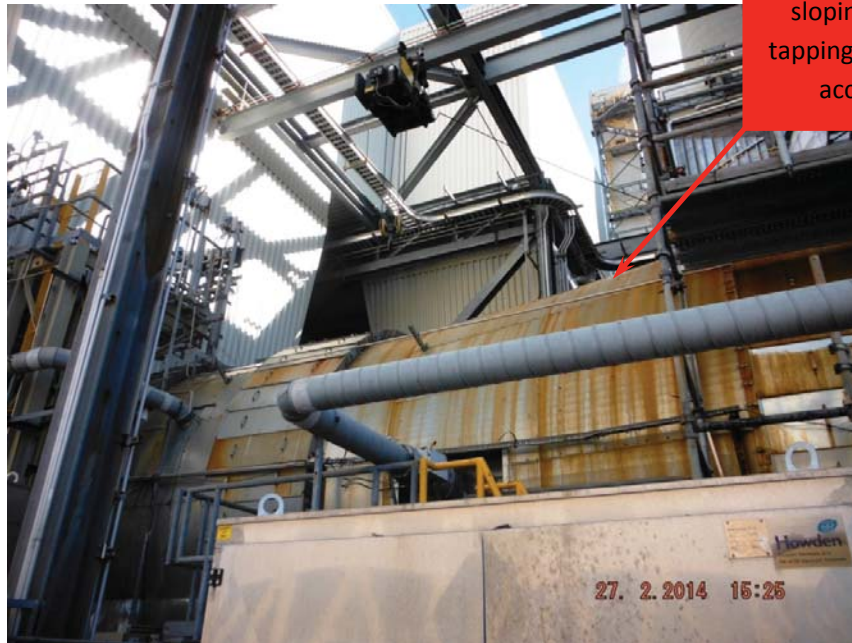
ID Fan A

Impulse pipe sloping towards tapping point and is acceptable

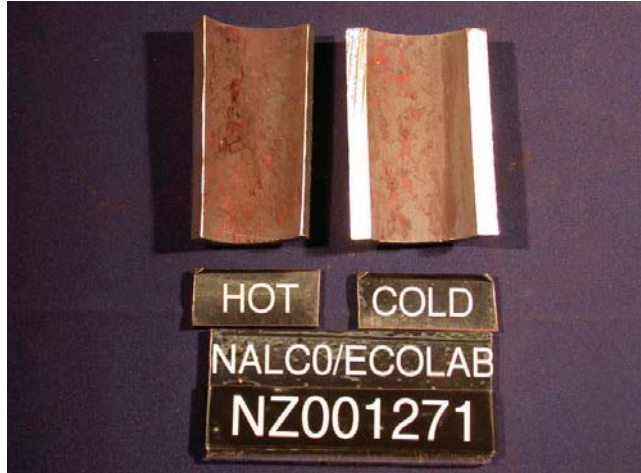
Before Cleaning

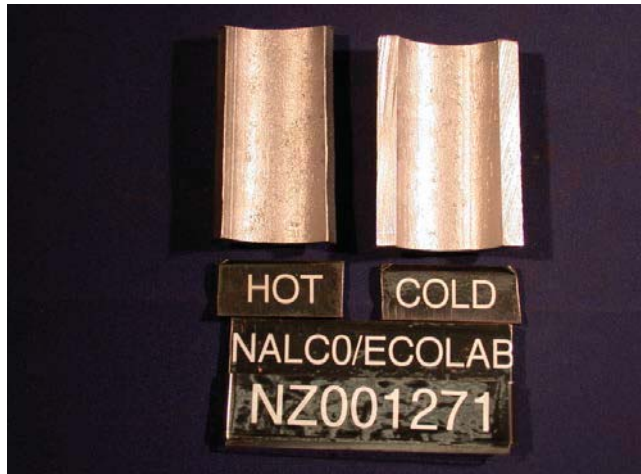
After Cleaning

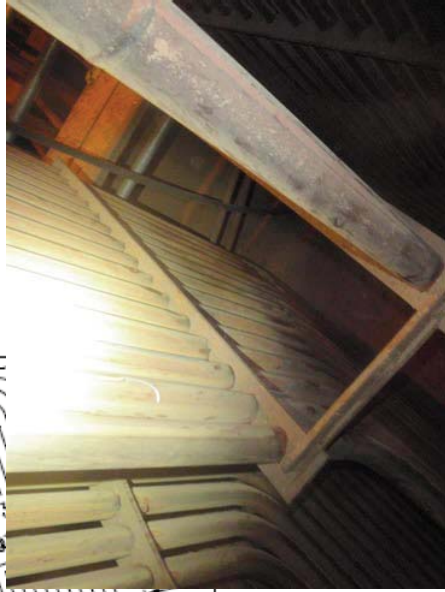
Final RH Pendants – Misalignment & Cupping

- Assembly to Assembly - 14 of 34 assemblies are within 1 tube diameter of each other at the rear
- Cupping - intra-assembly misalignment out of plain from the inside loop to the outside loop. Consider adding alignment system at rear side of assemblies.

Consider upgrading or installing additional alignment devices
