Assessment of Dam Safety Coal Combustion Surface Impoundments (Task 3) Final Report

American Electric Power
Big Sandy
Generating Station
Louisa, Kentucky

February 17, 2010

CHA Project No. 20085.7000.1510

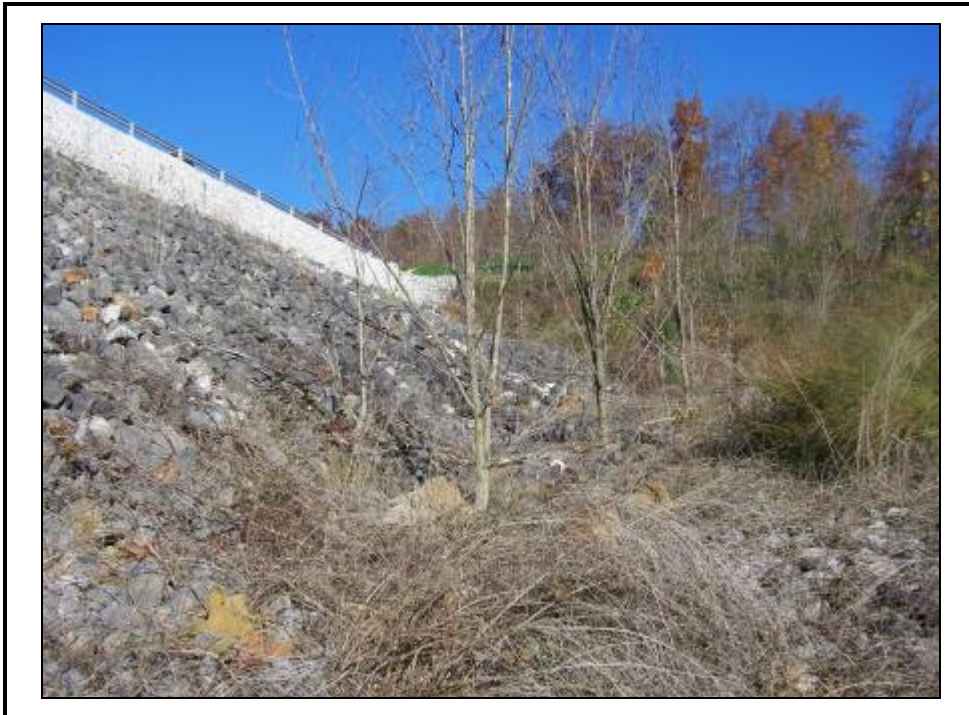
5

The upstream and downstream slopes were reasonably uniformly graded. The grass cover on the upstream slope appeared well maintained as shown in Photo 1. As shown in Photo 9, there is some grading irregularity on the south end of the upstream slope where the upstream slope meets the crest. The stone covered downstream slope appeared generally clear of vegetation as shown in Photo 2. However, brush and small trees were observed within the stone at the south and north groins (Photos 2 through 6). Plant personnel indicated that the small trees have been sprayed with herbicide.

Close-up of trees in north downstream groin.

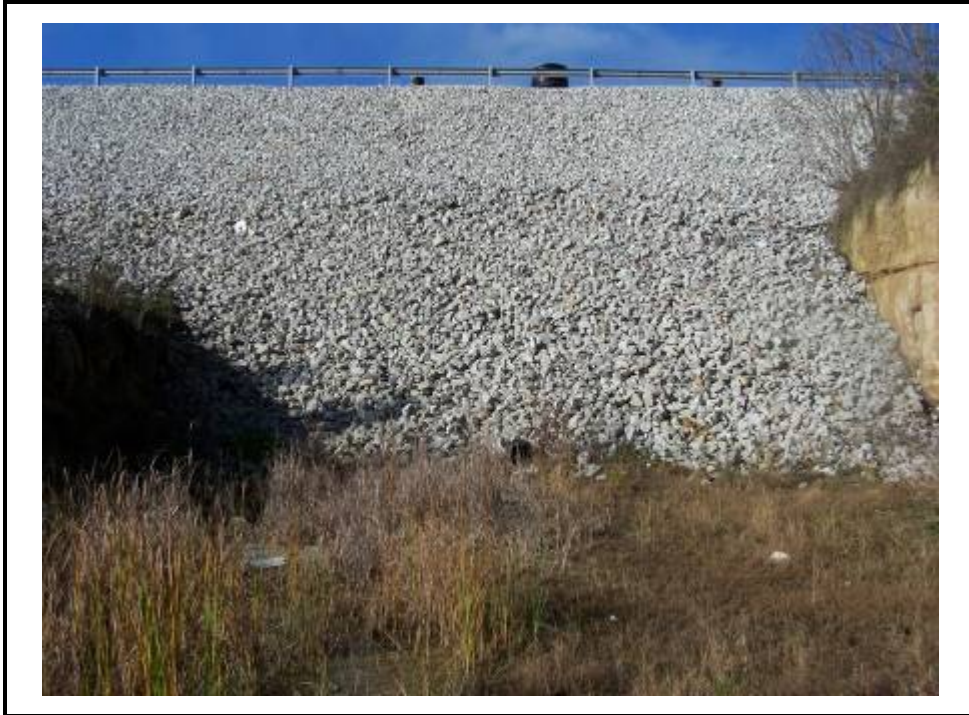
13

The Saddle Dam was constructed across the original emergency spillway, as shown in Photos 12 and 13, as part of the Phase 3 construction. A seepage drain is located within the old spillway as shown in Photos 7 and 14; plant personnel indicated that this drain has a constant flow. Apparent calcium deposits have formed at the seepage drain within the old emergency spillway as shown in Photo 14. Plant personnel indicated that the filter blanket materials for this seepage drain were derived from crushed limestone which is readily available in the area. A “new” emergency spillway was constructed at the north abutment of the Saddle Dam as shown in Photos 15 and 16. The Emergency Spillway outlet and inlet are shown in Photos 17 and 18, respectively.

Downstream slope of Saddle Dam filling original emergency spillway.

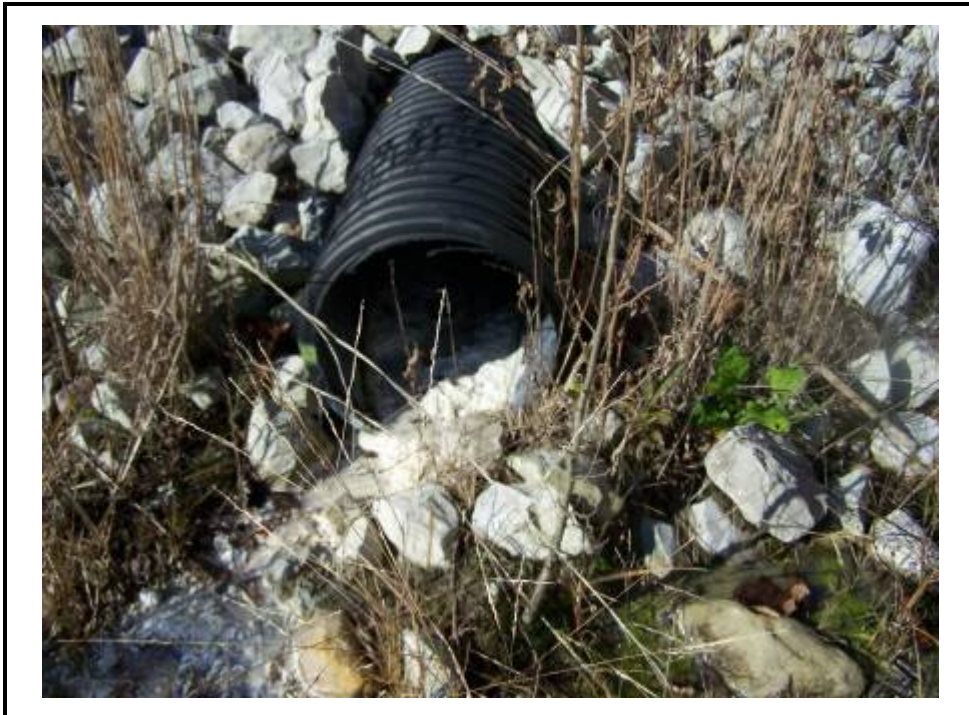
14

Seepage drain from original emergency spillway plug.
Note calcium deposits from granular fill used in filter blanket.

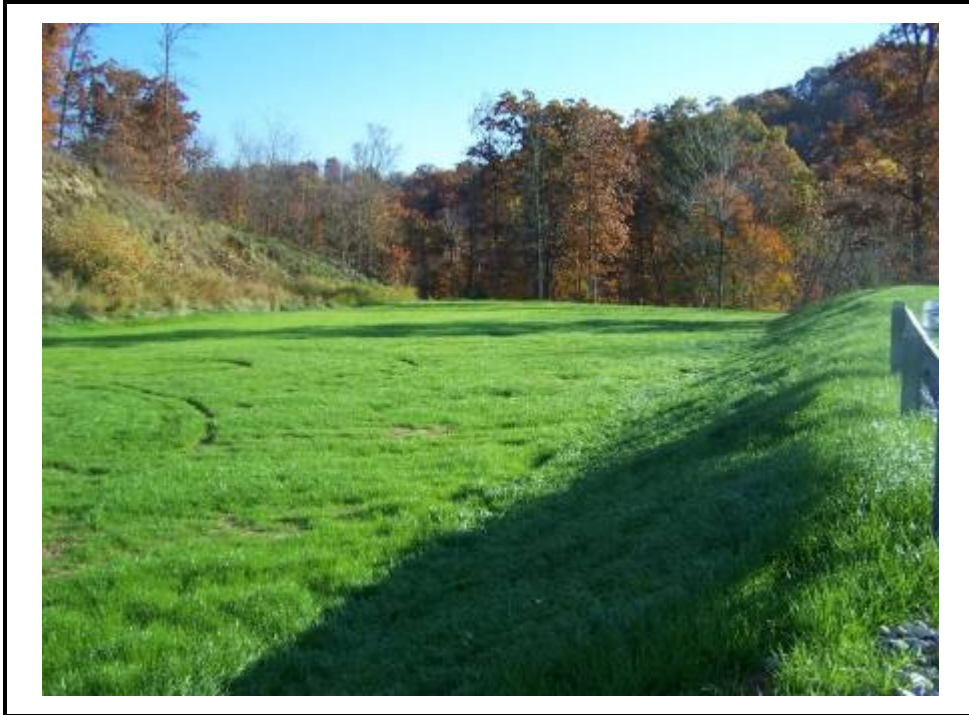
15

“New” emergency spillway at north abutment of Saddle Dam.

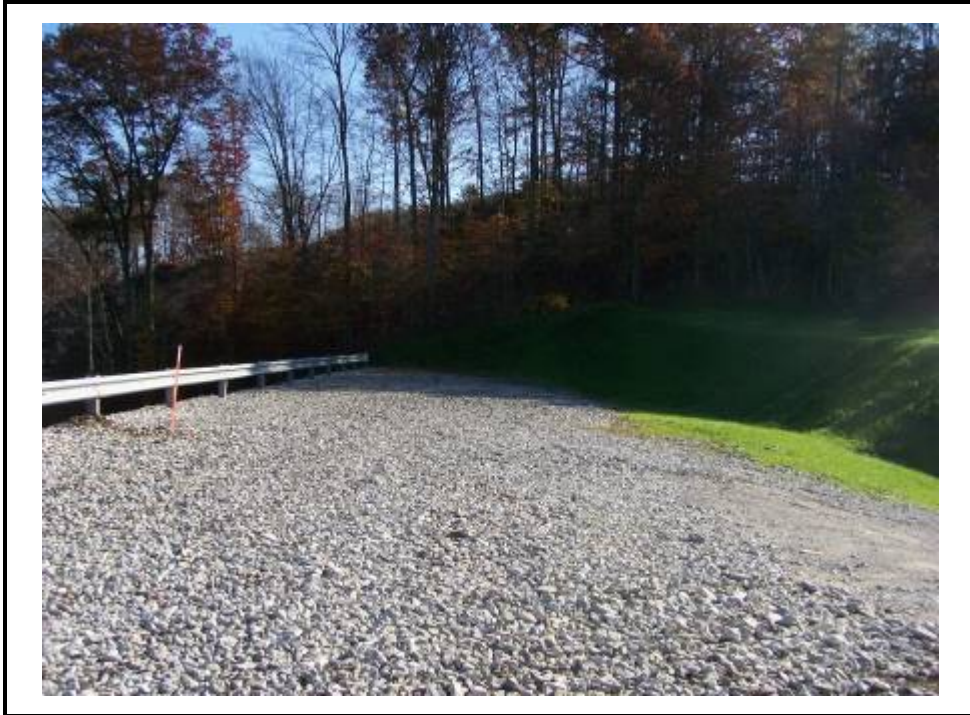
19

East abutment and crest of Horseford Creek Dam, looking east.

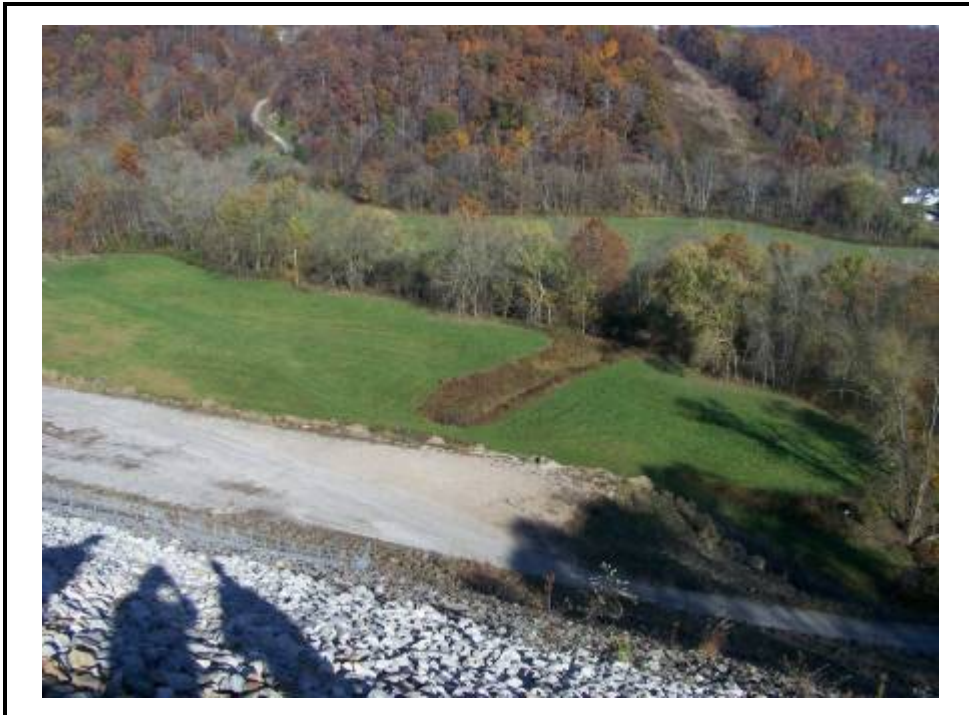
22

Downstream slope and buttress of Horseford Creek Dam looking north.
Channel in field is original discharge channel which is now abandoned.

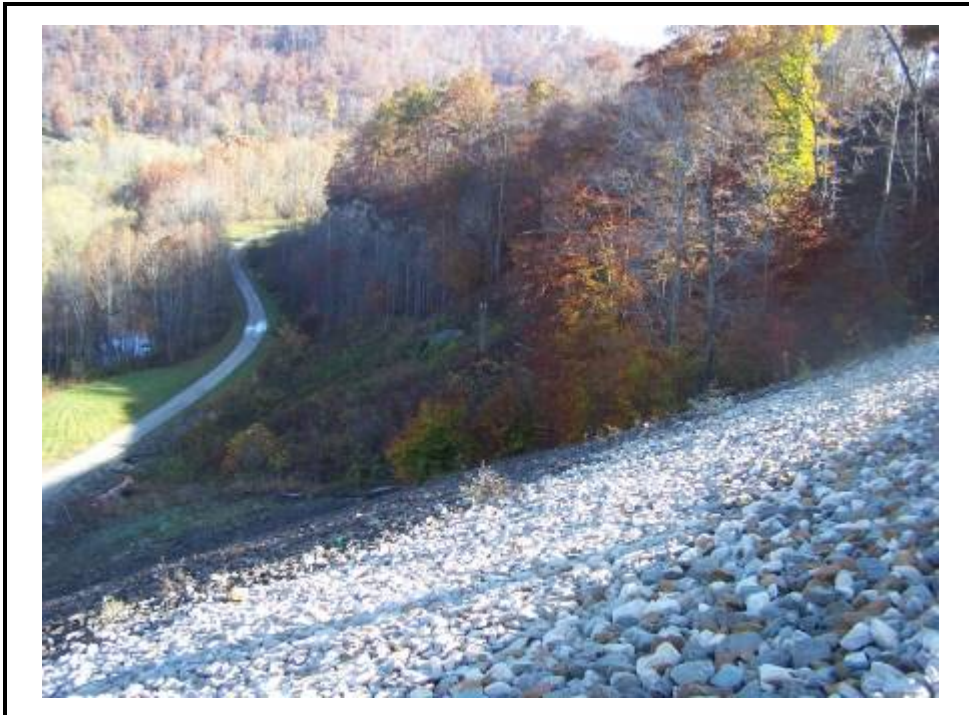
24

East abutment of Horseford Creek Dam, looking northeast.

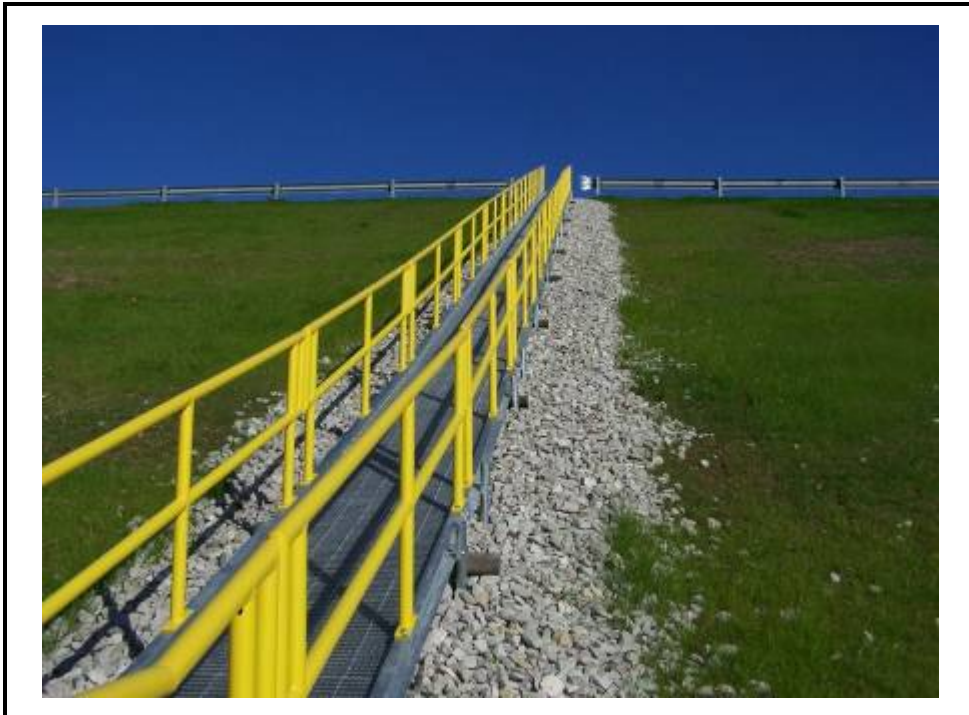
31

Access ramp to Horseford Creek Dam outlet structure.

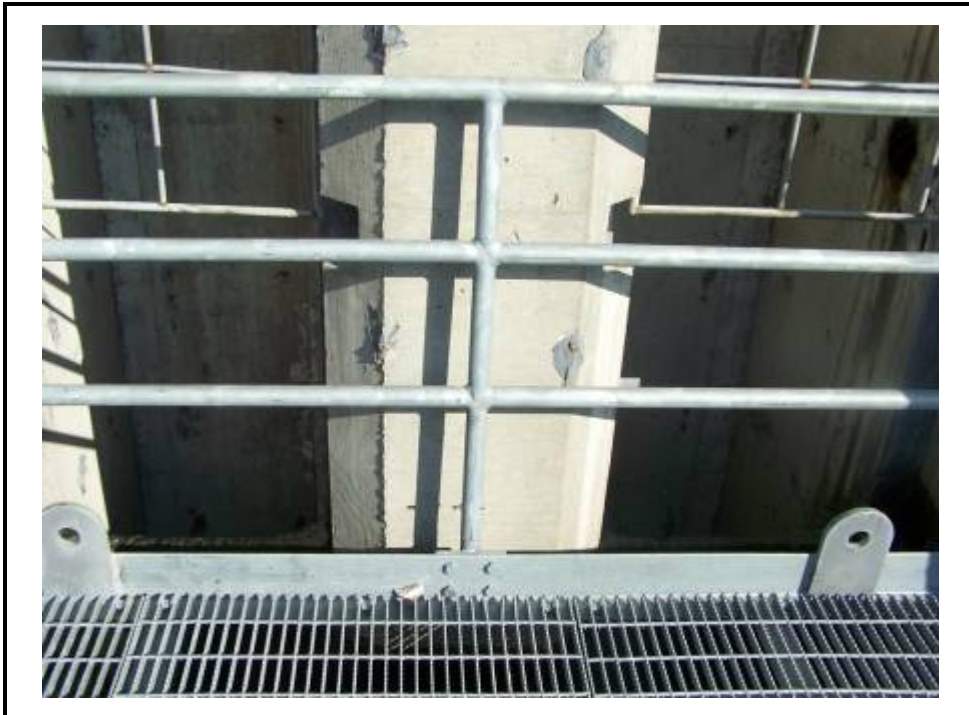
32

Twin stop log opening at Horseford Creek Dam outlet structure.

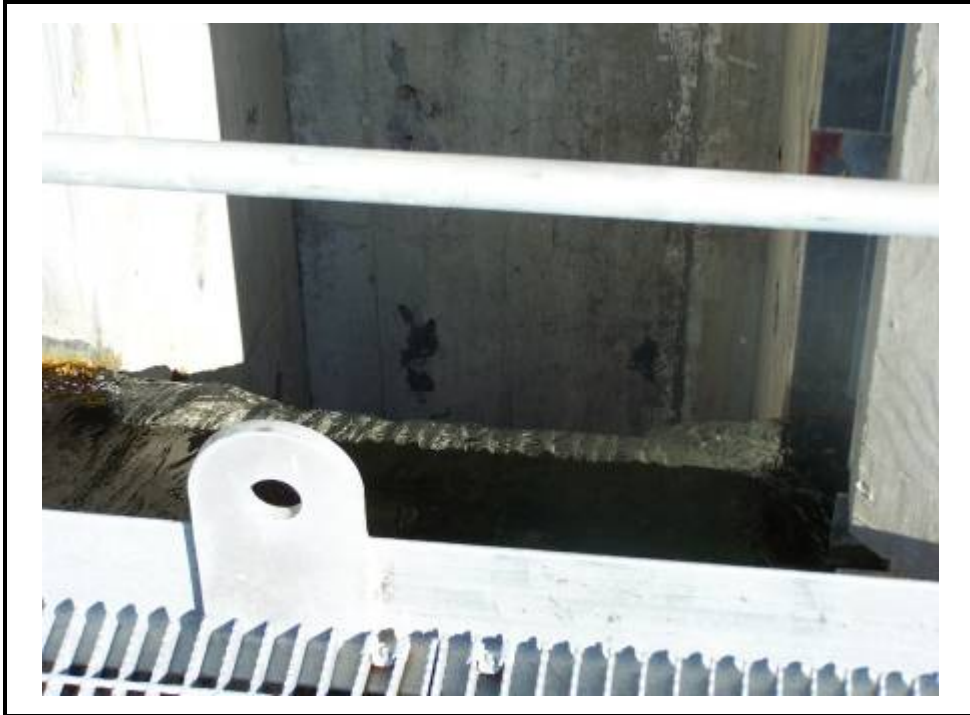
33

Close-up on one stop log opening at Horseford Creek Dam outlet structure.

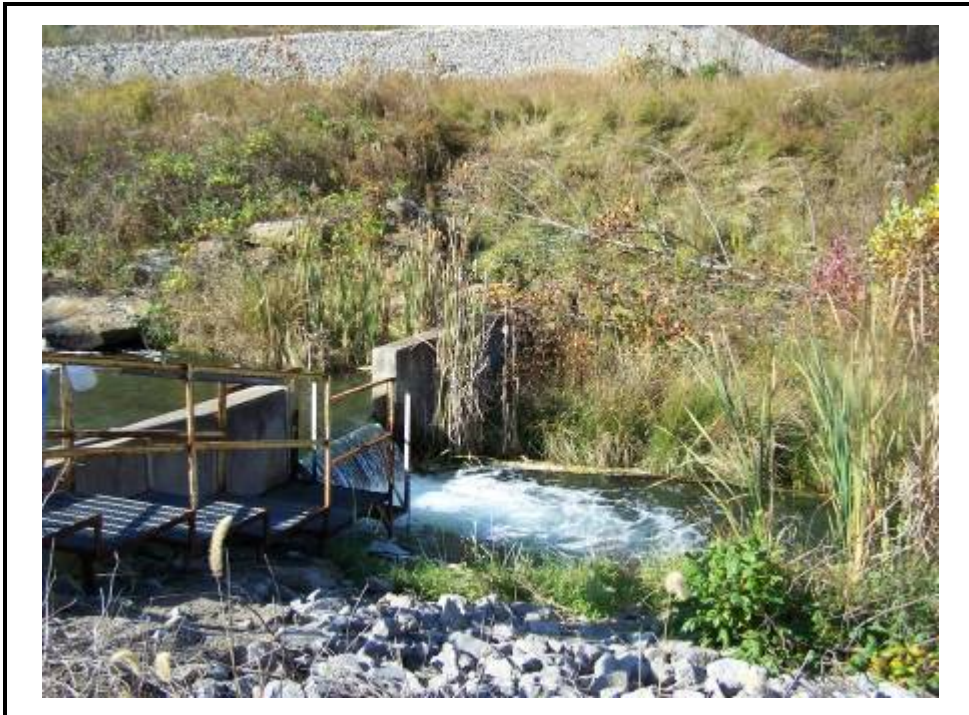
36

Stilling basin and NPDES outfall for Horseford Creek Dam outlet.

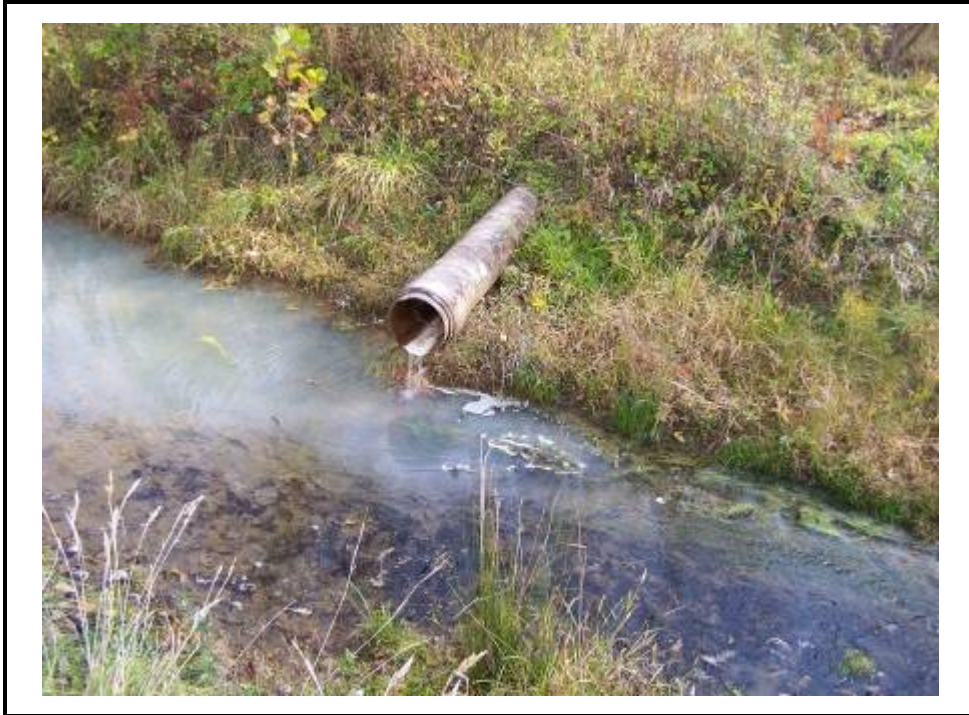
39

Drain pipe from east abutment area of Horseford Creek Dam.
Note calcium deposits in water from limestone formations.

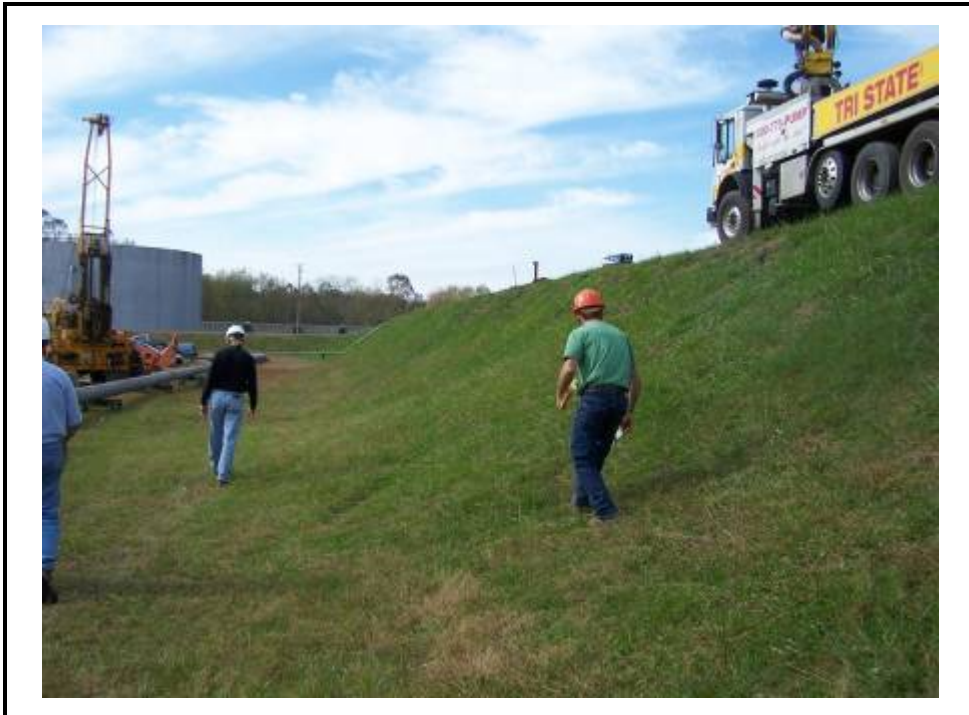
44

Downstream slope of South Dike at the Bottom Ash Complex along the south Bottom Ash Pond.

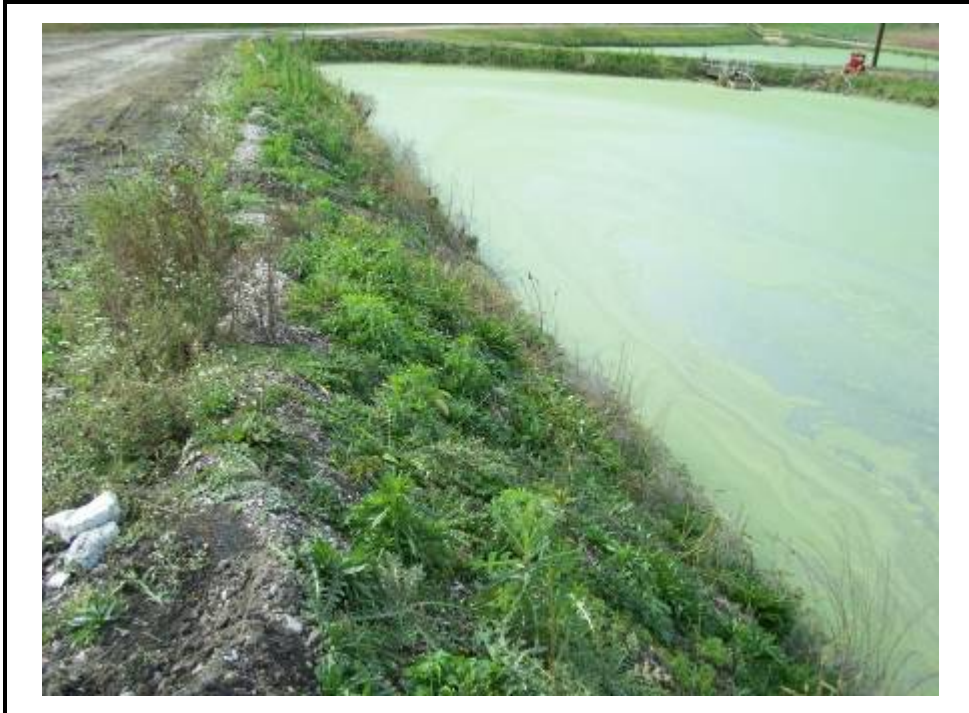
47

Upstream slope of South Dike of Bottom Ash Complex at south Clearwater Pond, looking west.

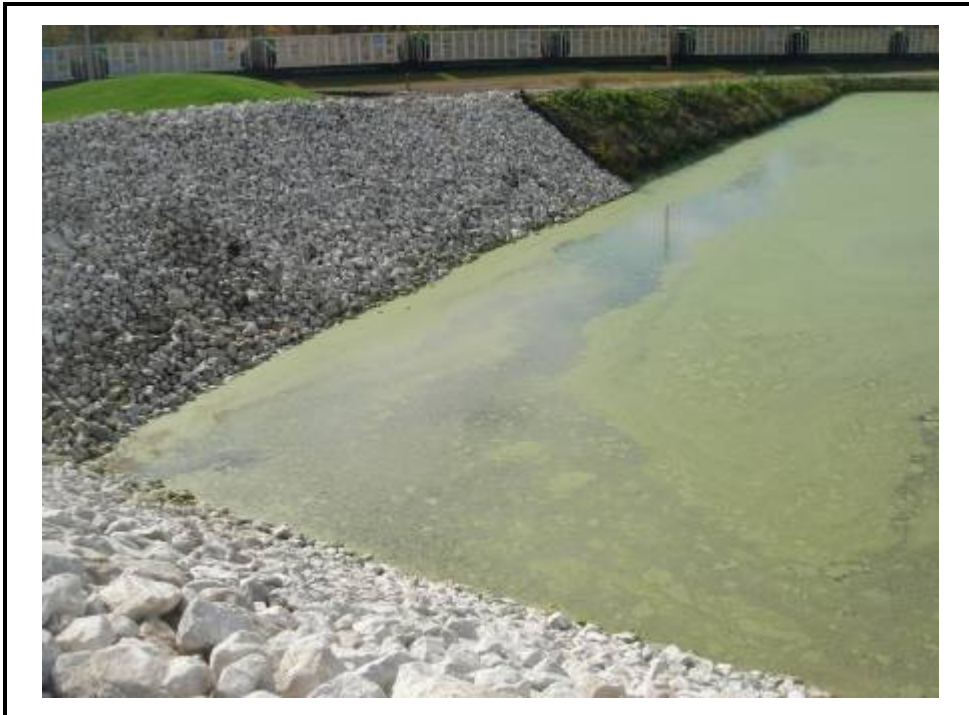
48

Upstream slope of South Dike of Bottom Ash Complex at south Clearwater Pond, recently placed rip rap protection at east end.

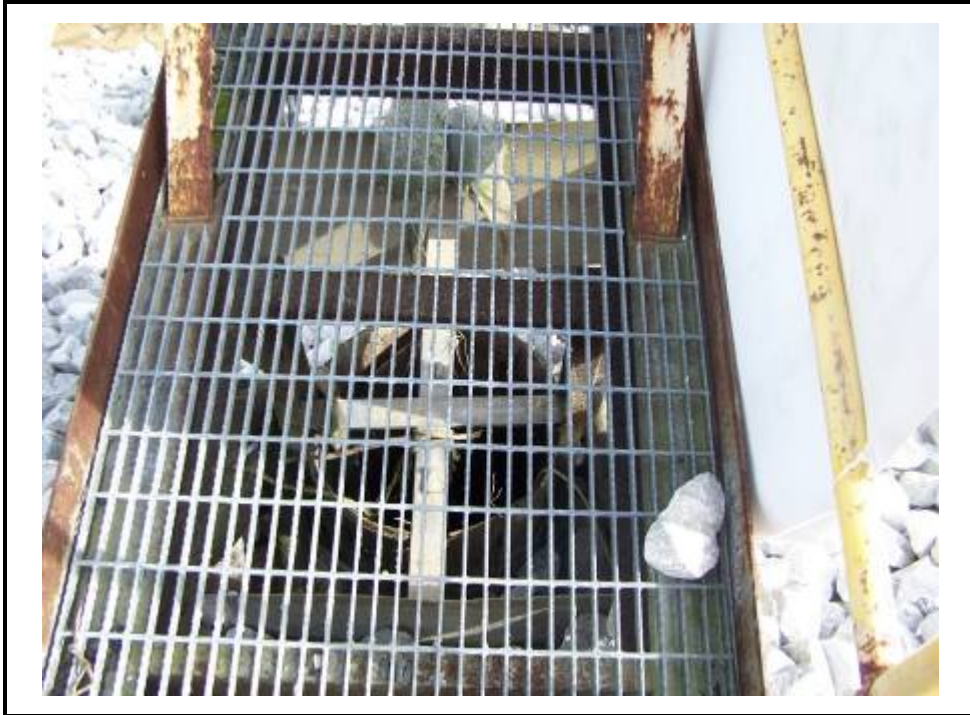
51

Close-up of south Bottom Ash Pond decant structure.

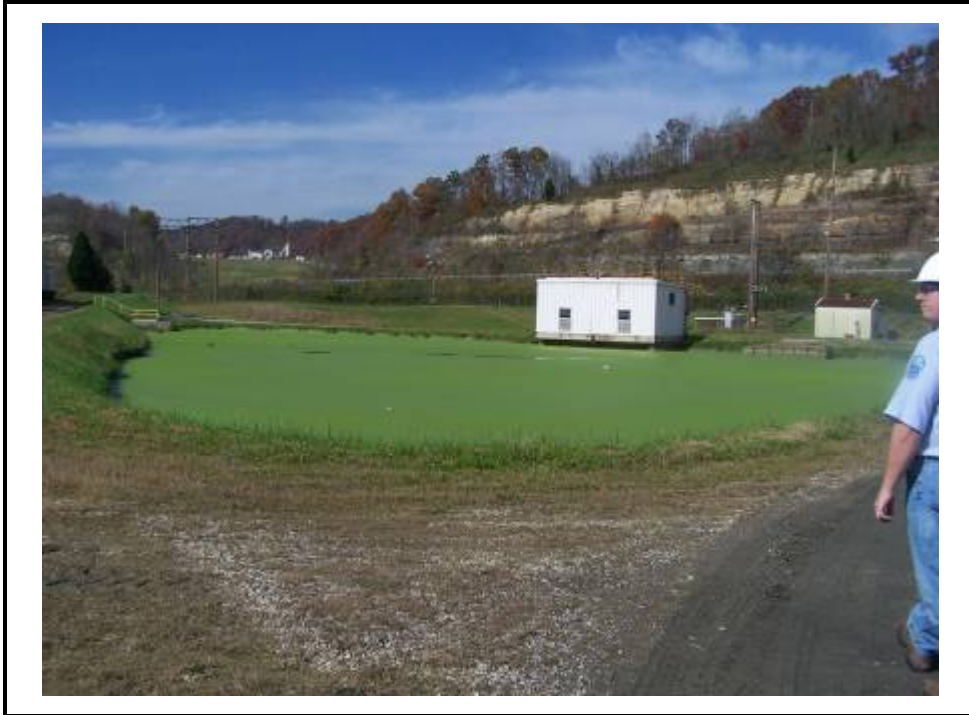
55

Reclaim Pond (incised) looking west. Building is the pump station which diverts flows back to the plant or to Horseford Reservoir. At west end of pond is a non-permitted overflow to the Big Sandy River.

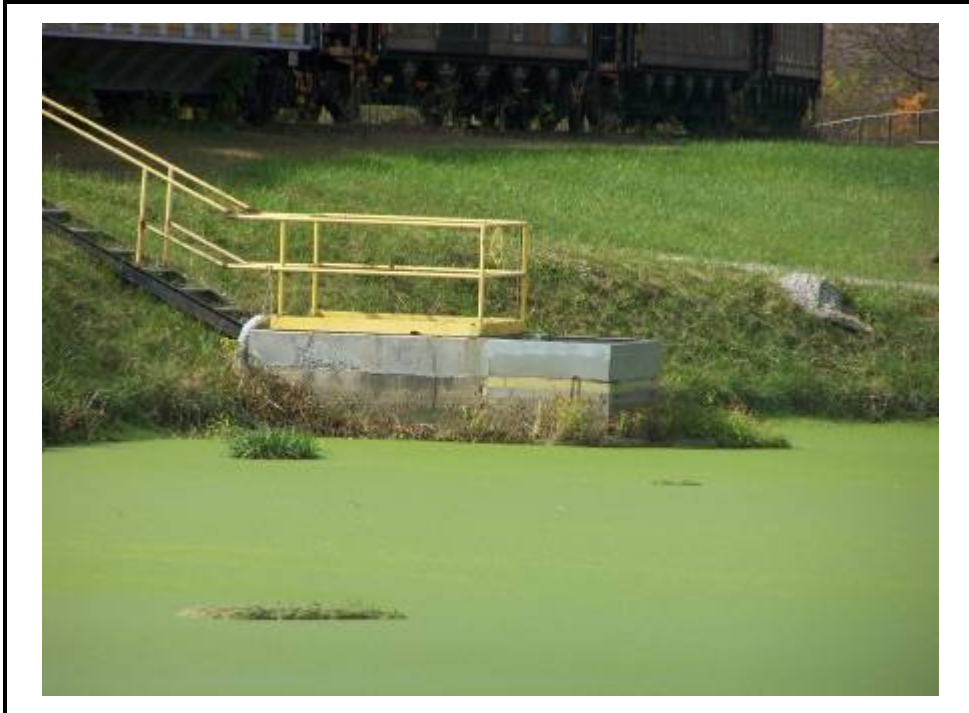
57

Close-up of non-permitted overflow to the Big Sandy River. Plant Personnel indicated that when water level reaches yellow line on the structure, pumping is initiated to Horseford Reservoir to prevent discharge to the river.

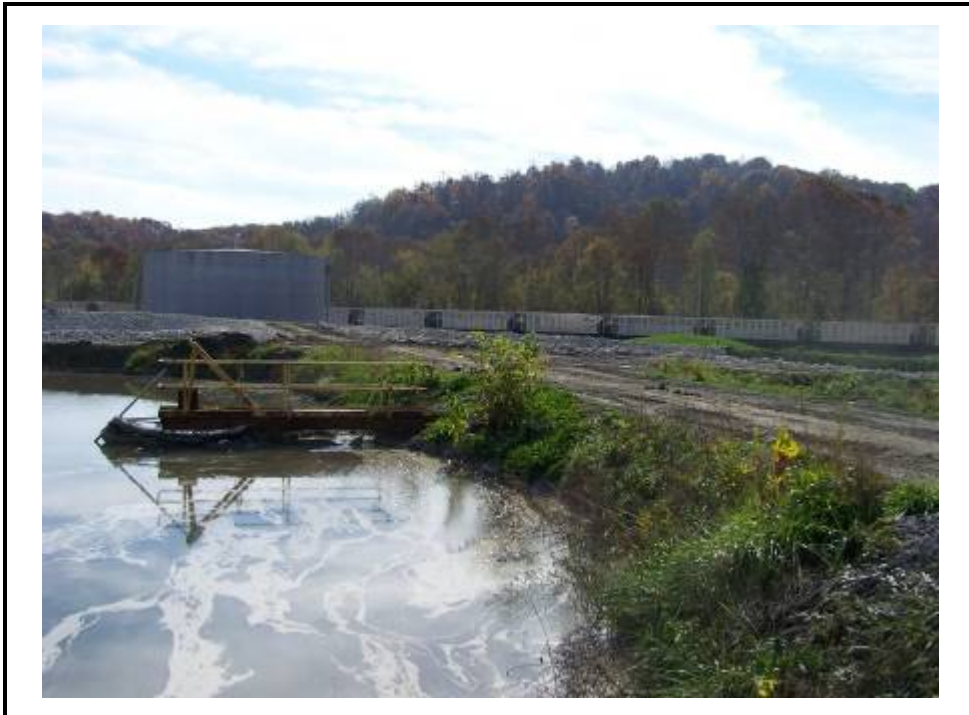
62

East slope of Splitter Dike between north Bottom Ash and Clearwater Ponds and decant structure.

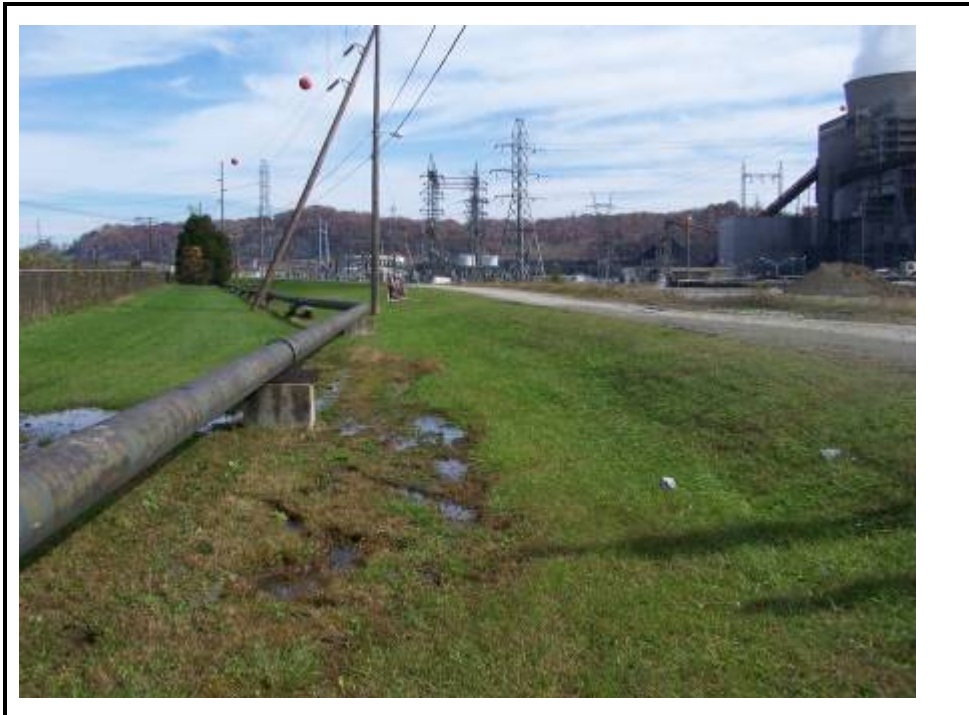
66

Downstream slope of North Dike and Bottom Ash Complex adjacent to north Bottom Ash Pond, looking east.
Note that the north side of the Bottom Ash Complex is largely incised.

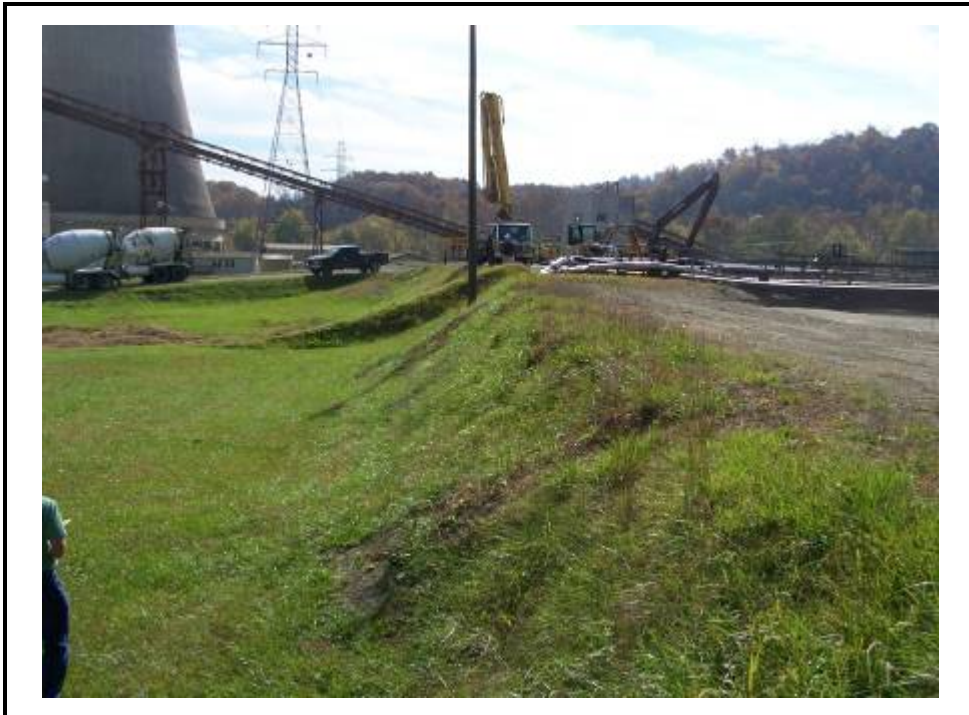
68

Downstream slope of East Dike of the Bottom Ash Pond, looking south.

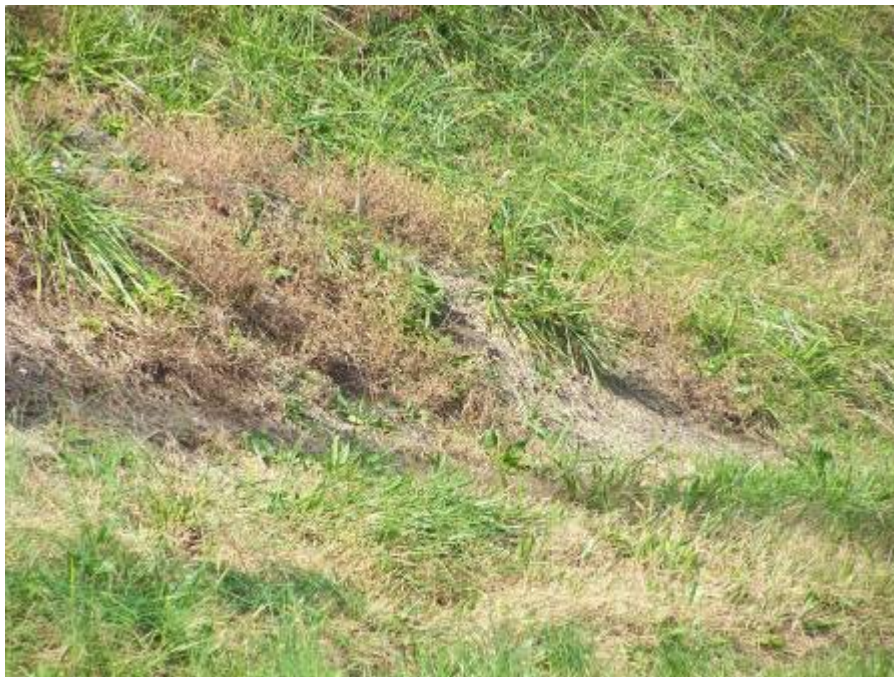
70

Minor sloughing or erosion on downstream slope of East Dike.
