Louisville Gas and Electric Company
2022 Annual Report
Case No. 2017-00119

In accordance with the Kentucky Public Service Commission's Order of March 16, 2018 in Case No. 2017-00119, Louisville Gas and Electric Company ("LG&E") is submitting the fifth and final annual report for the years 2018– 2022. The annual report provides the completion of the implementation of LG&E's Action Plan and the number of bolted-style coupling systems removed in 2022 from distribution lines having an operating pressure in excess of 60 psig along with observations of the removed couplings. LG&E has completed all requirements of the order.

Distribution Couplings removed from the ground:

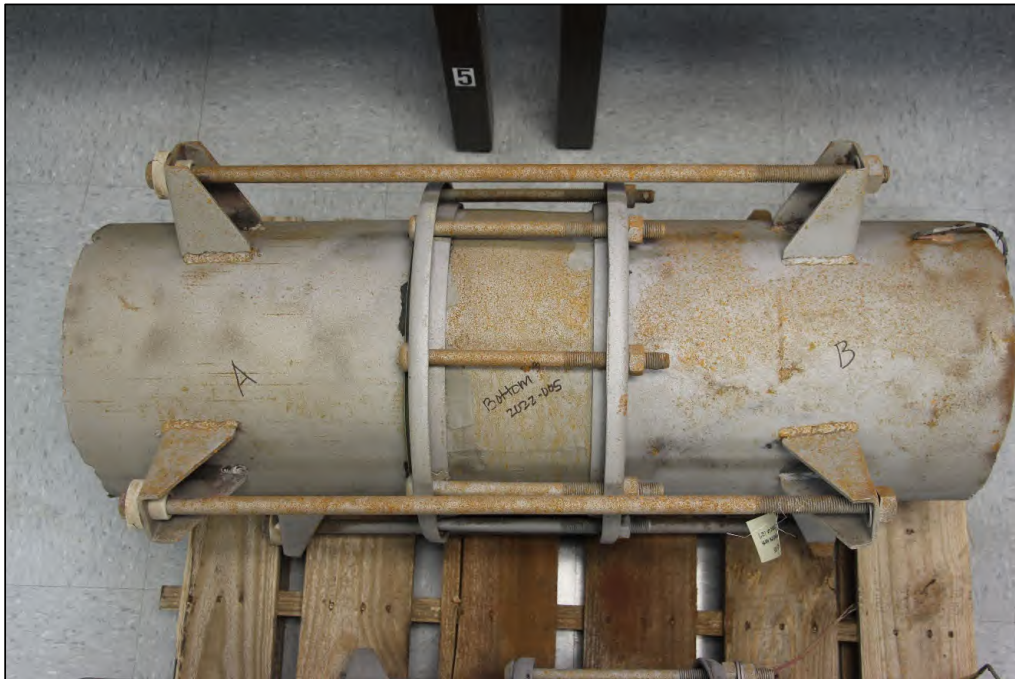
Figure 2. Photograph of the bottom of the submitted sample.

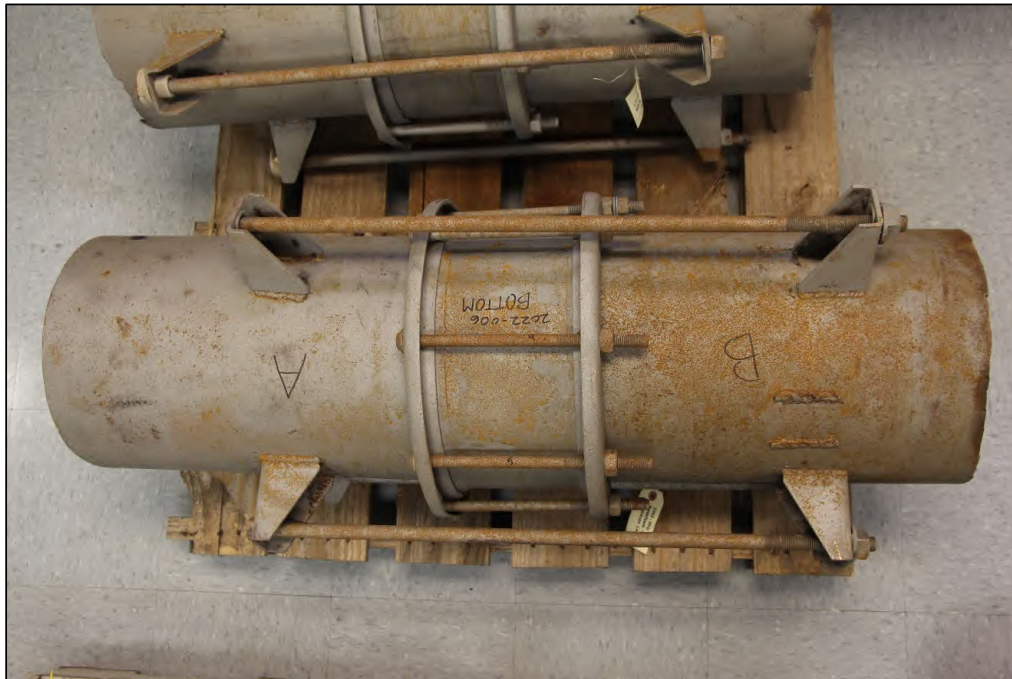
Figure 2. Photograph of the bottom of the submitted sample.

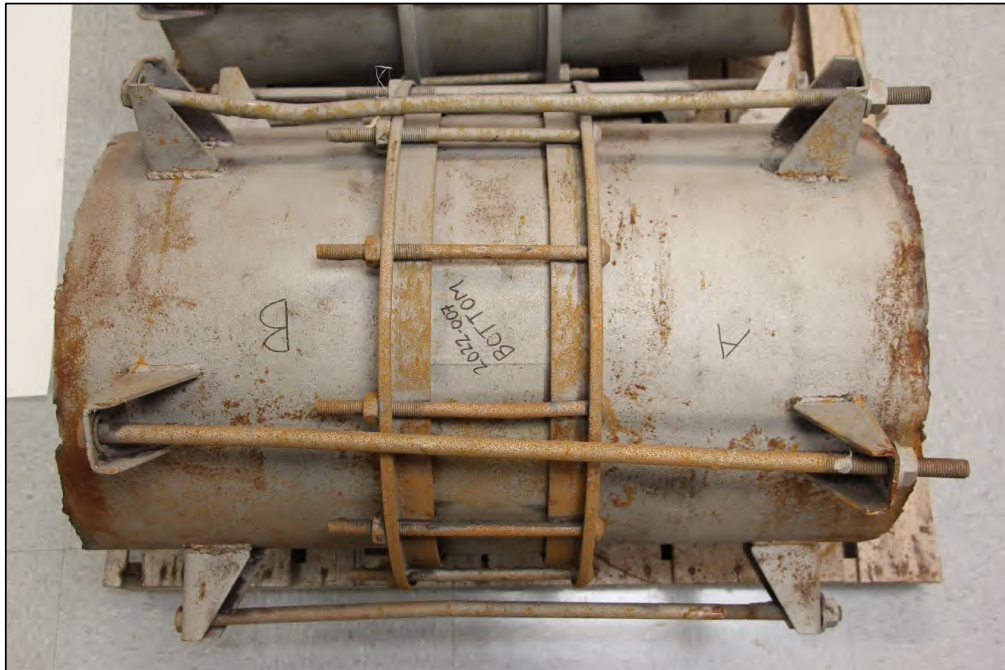
Figure 2. Photograph of the bottom of the submitted sample.

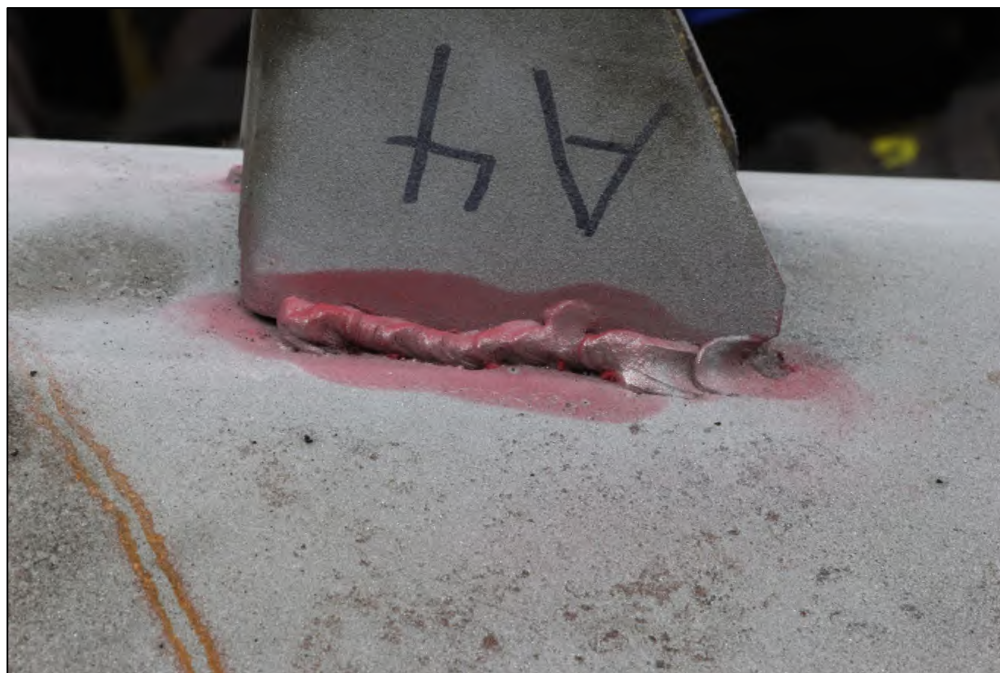
The two separated ends of the disassembled coupling were sent to a third party NDE laboratory for inspection. Visual and liquid dye penetrant inspections were performed on the lug attachment welds. Inspection was performed in accordance with the acceptance criteria of API 1104 “Welding of Pipelines and Related Facilities”. The inspection results are provided as Appendices A and B. Two representative welds are shown in Figures 11 and 12 with the dye penetrant test media remaining.

Figure 11. Image of the Lug A4 exterior top weld after dye penetrant media had been used during inspection.
