**COMMONWEALTH OF KENTUCKY
BEFORE THE PUBLIC SERVICE COMMISSION**

**ELECTRONIC APPLICATION OF)
BLUEGRASS WATER UTILITY)
OPERATING COMPANY, LLC FOR AN) Case No. 2022-00432
ADJUSTMENT OF SEWAGE RATES)**

DIRECT TESTIMONY

JACOB FREEMAN

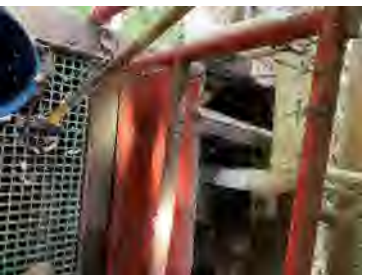
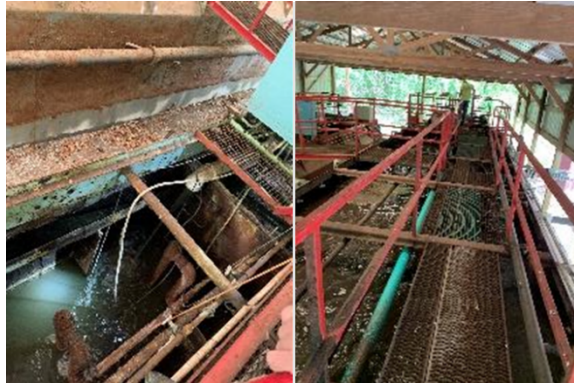
Examples of severe rust damage present throughout the facility before repairs

A. The River Bluffs rust issues needed to be repaired to: (1) ensure that the tanks did not leak untreated wastewater into the environment, (2) maintain proper treatment processes, (3) allow for safe operation, and (4) extend the useful life of the plant.

A. Yes. Bluegrass Water realized that repairs would necessarily include: (1) replacing damaged catwalks; (2) patching tank leaks; and (3) replacing damaged sections of wastewater plant piping and air headers. As the system was evaluated during operations, however, it became clear that the number of air leaks and the deteriorated aeration diffusers had reduced the efficiency of aeration treatment. As a result, replacement of the aeration

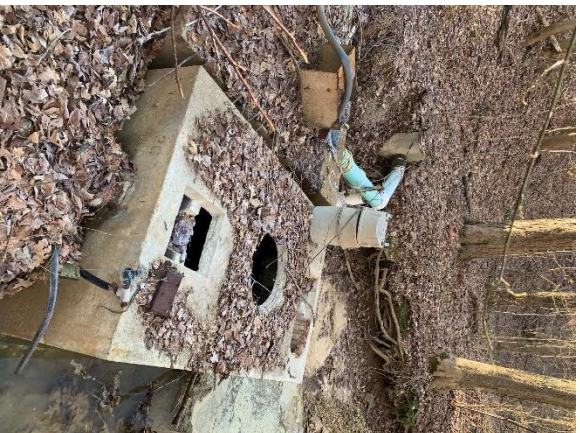
Before and after contact chamber removal and new dechlorination tablet feeder

4 A. Yes, the renovations at the Airview facility have continued, and facility performance has
5 improved. The damaged contact chamber has been removed from the creek, and the
6 accumulated sludge has been removed. This included the installation of a proper tablet
7 feeder for dechlorination following disinfection, preventing damage to aquatic life in the
8 creek from chlorine residuals. Additionally, the severely corroded influent bar screen has
9 been replaced, preventing nuisance solids from entering the treatment process which
10 previously resulted in poor operational performance and damage to aeration piping.
11 Finally, the repairs and recoating of the tank exterior and handrail installation were
12 completed at the Airview facility. This will ensure operator safety and prevent leaks and
13 further deterioration of the tank infrastructure.

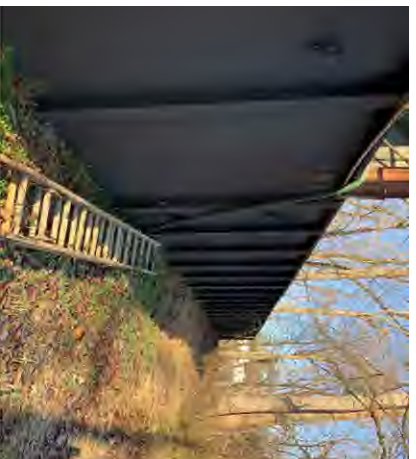
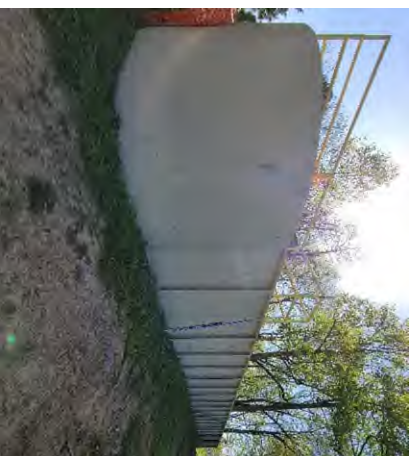
Before and after tank exterior rehabilitation and handrail installation.

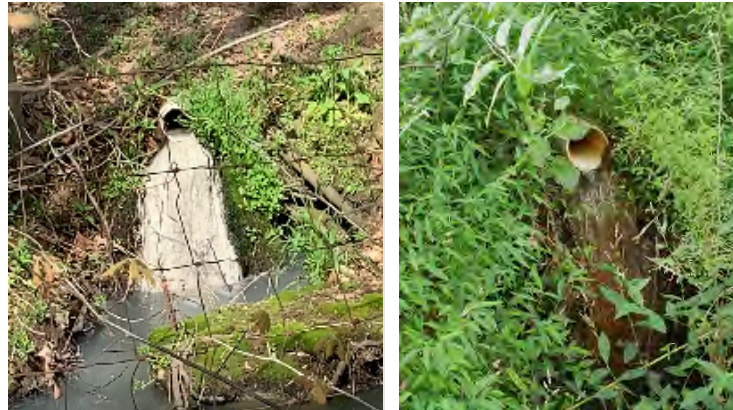
12 A. Yes, Bluegrass Water’s investigation into the problems at Golden Acres showed that
13 system flows were primarily caused by a very poorly configured effluent pipe
14 characterized by two sharp turns. These elbows resulted in resistance to flows (especially
15 during high flow periods) causing water to backup into the plant and ultimately to water
16 overtopping the facility tanks. The problem was compounded by the fact that once the
17 facility overflowed, water carried debris into the effluent pipe which further restricted
18 effluent flow.

7 *Before and after effluent quality. Note white discolored effluent and debris (mostly white toilet*
8 *paper forming something akin to papier mâché) prior to improvements, and dramatic*
9 *improvement to clear effluent following resolution.*

19 Since the last case, the effluent pipe has been replaced with a larger pipe and
20 rerouted to eliminate the sharp turns in the piping. This has the beneficial effect of
21 preventing backups and flooding. As a result, the treatment process has been restored and
22 effluent quality improved. Finally, these improvements prevent the premature
23 deterioration of equipment that had become submerged during flooding events.

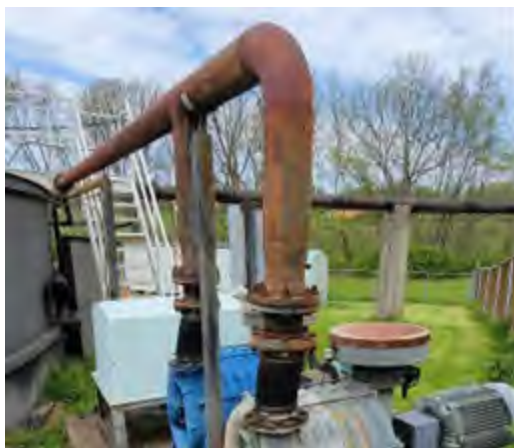
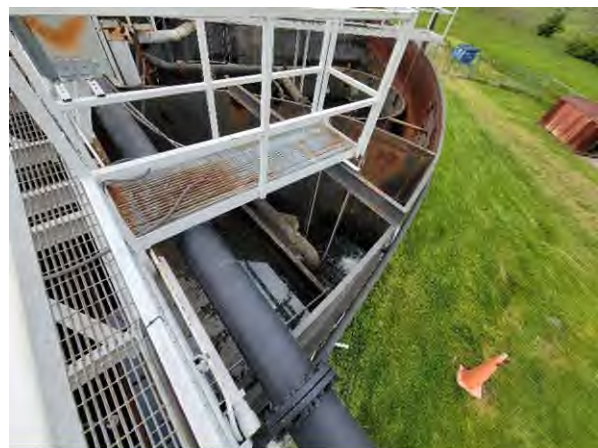
Notable rust on air header, walkways, tank, and transfer piping.

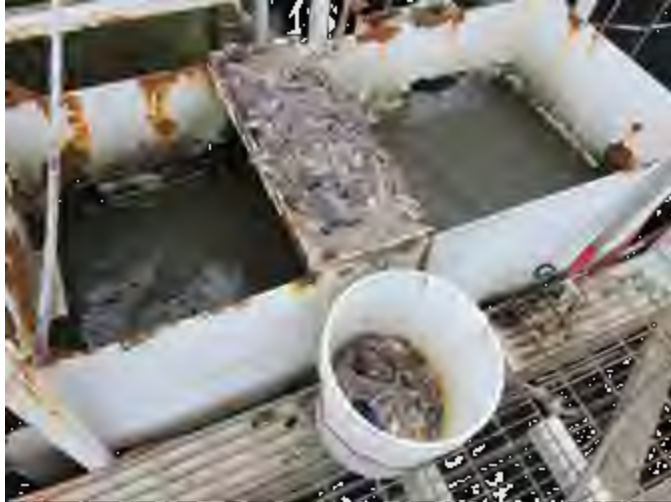
Examples of nuisance solids at Delaplain.

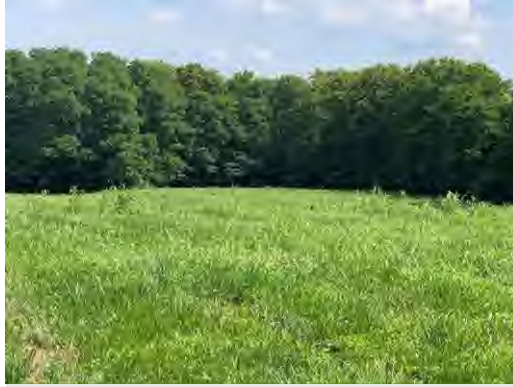
Overgrowth on irrigation fields.

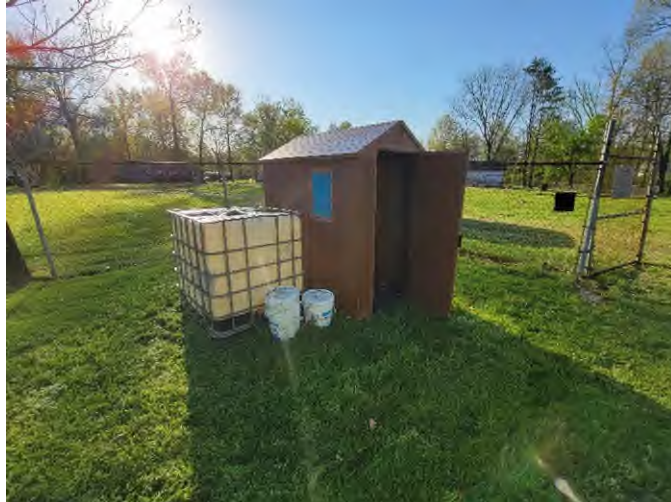
New storage shed.
