Phase I Environmental Site Assessment

Frontier Solar Site

Marion and Washington Counties, Kentucky

19 January 2024

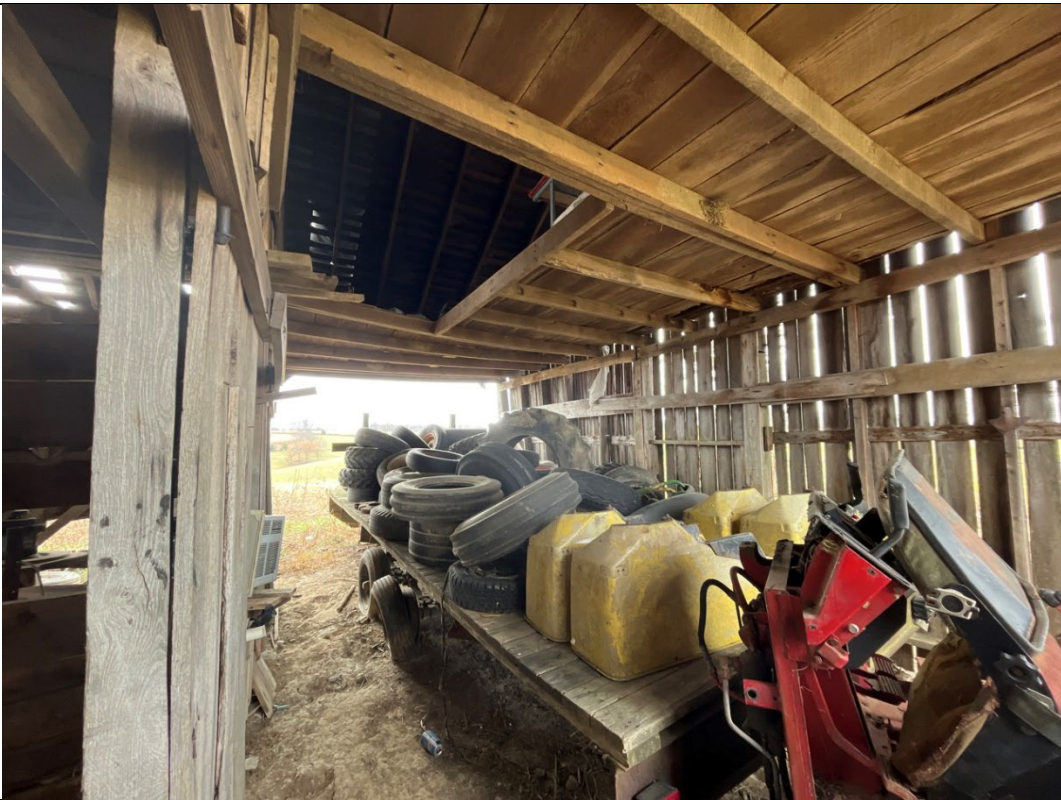
Photograph: 6 View of tires located within an on-site barn.

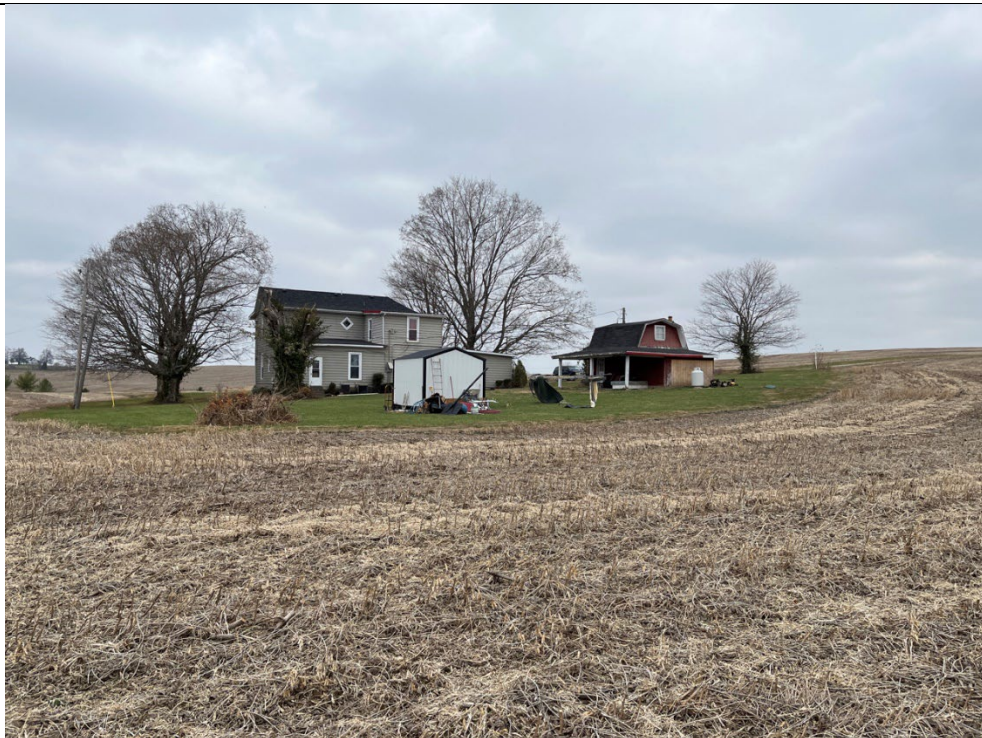
Photograph: 12 | View of a residence, shed, barn, and propane AST.

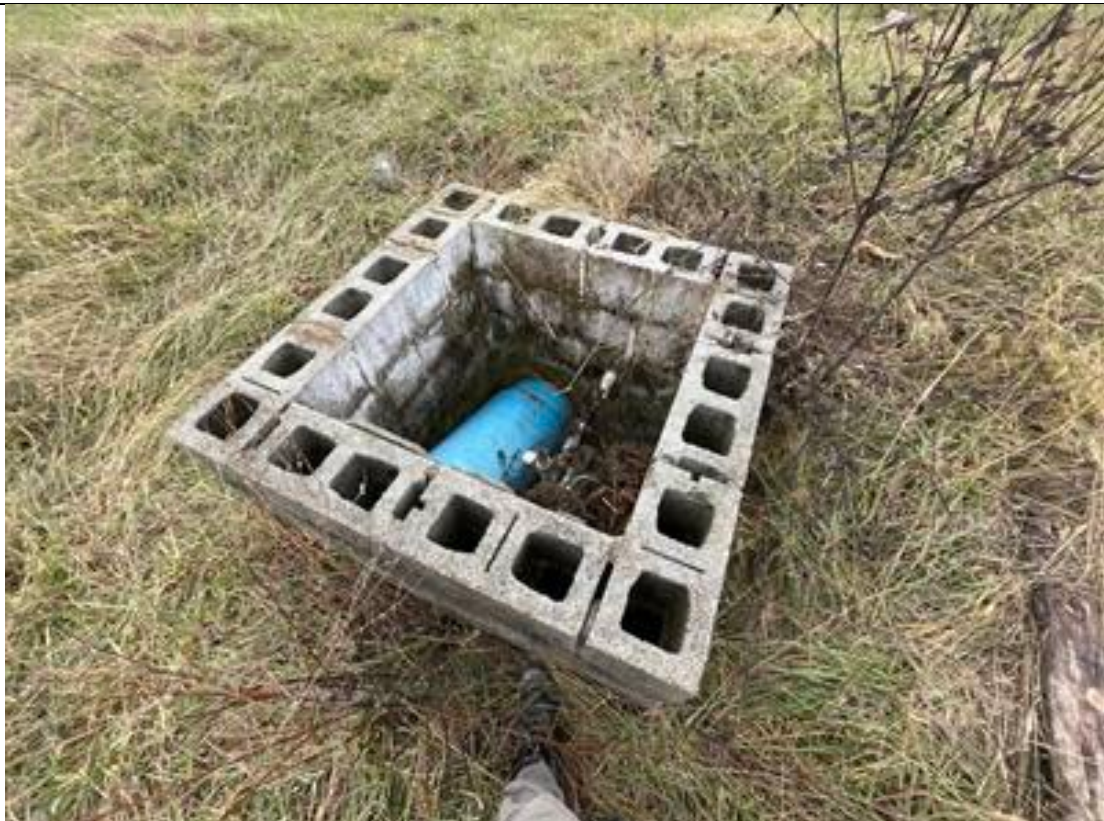
Photograph: 16 | View of a well pump.

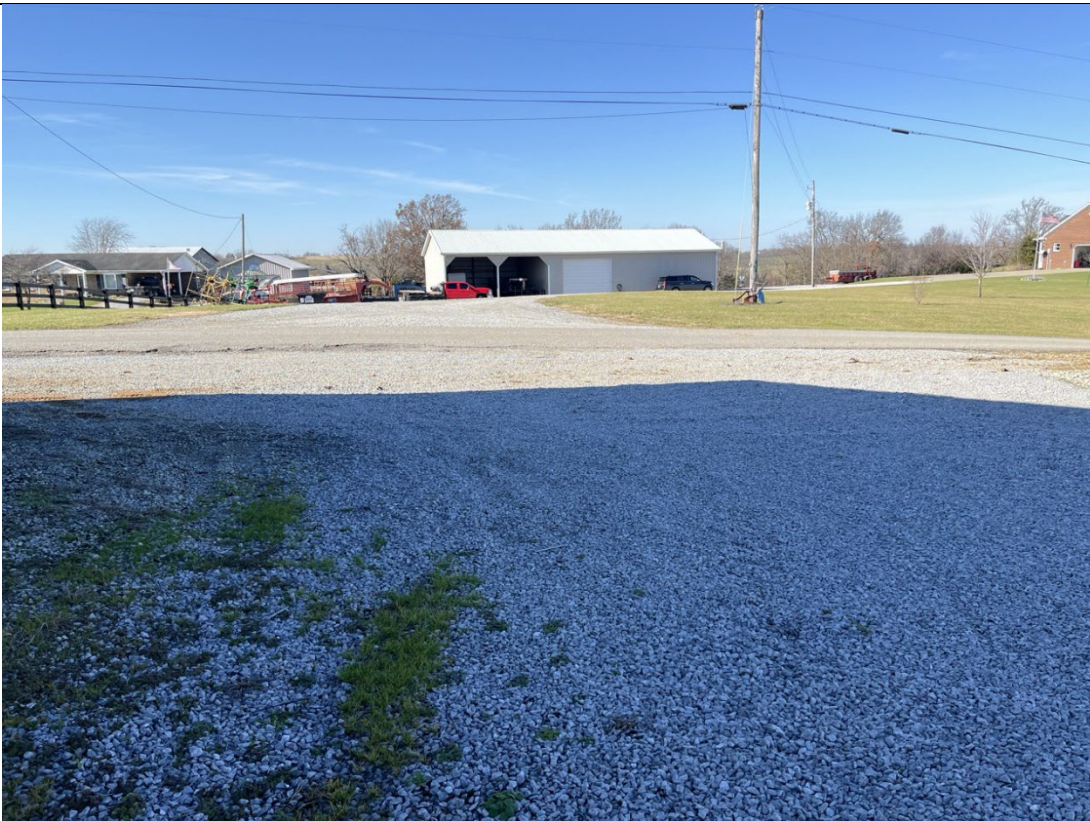
Photograph: 26 | View of a residence, shed, barns, and transformer along McLain Rd.

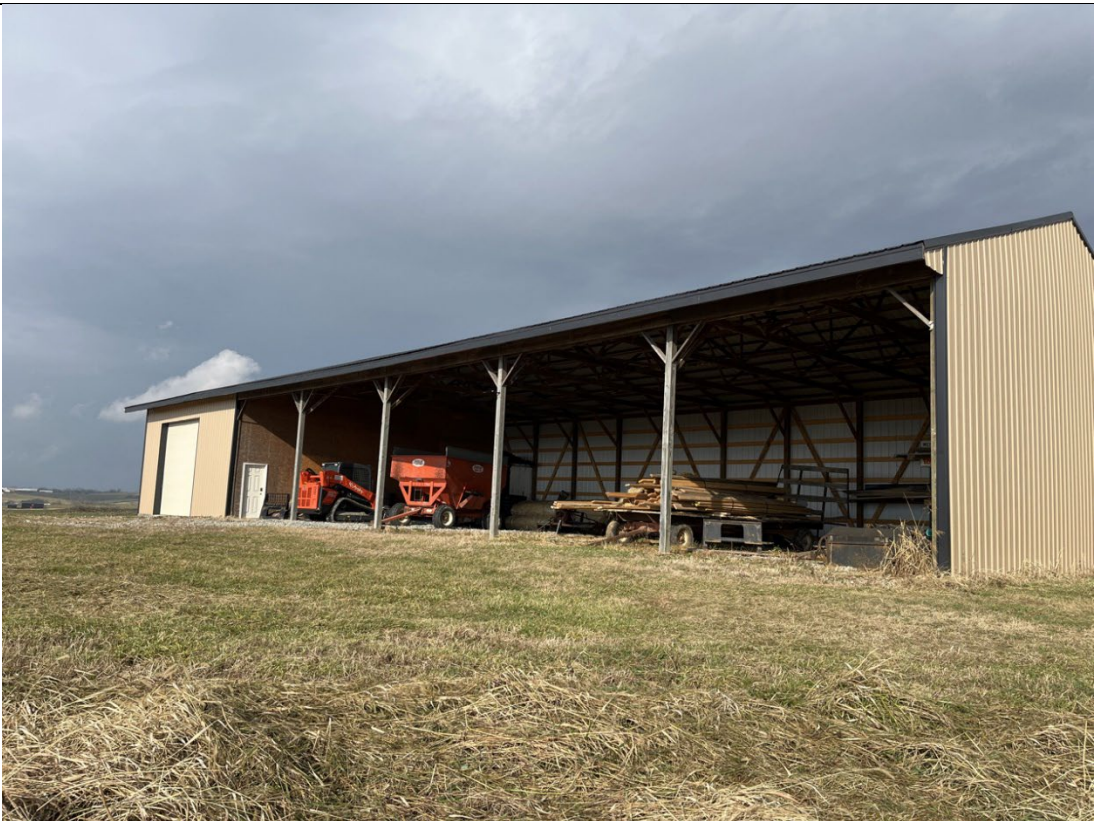
Photograph: 34 | View of machinery stored within an on-site barn.

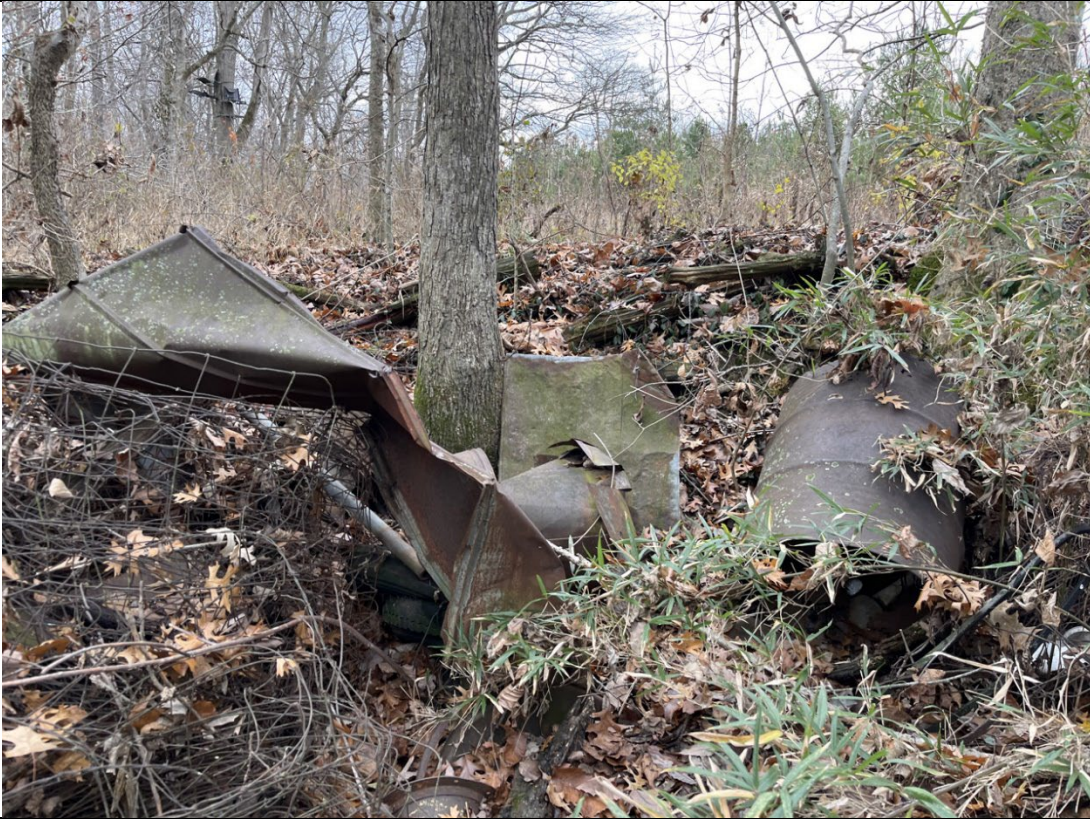
Photograph: 35 View of dumb site with metal drums along Servant Run.

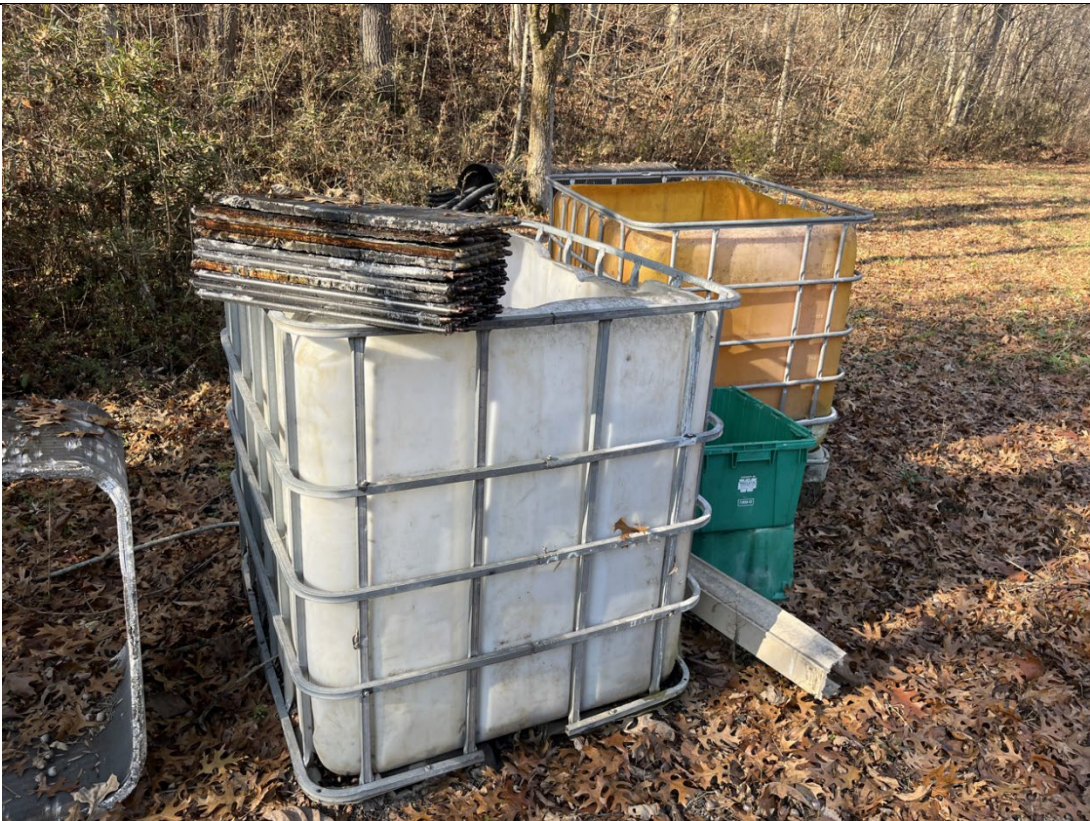
Photograph: 36 View of miscellaneous AST with piping along Servant Run.

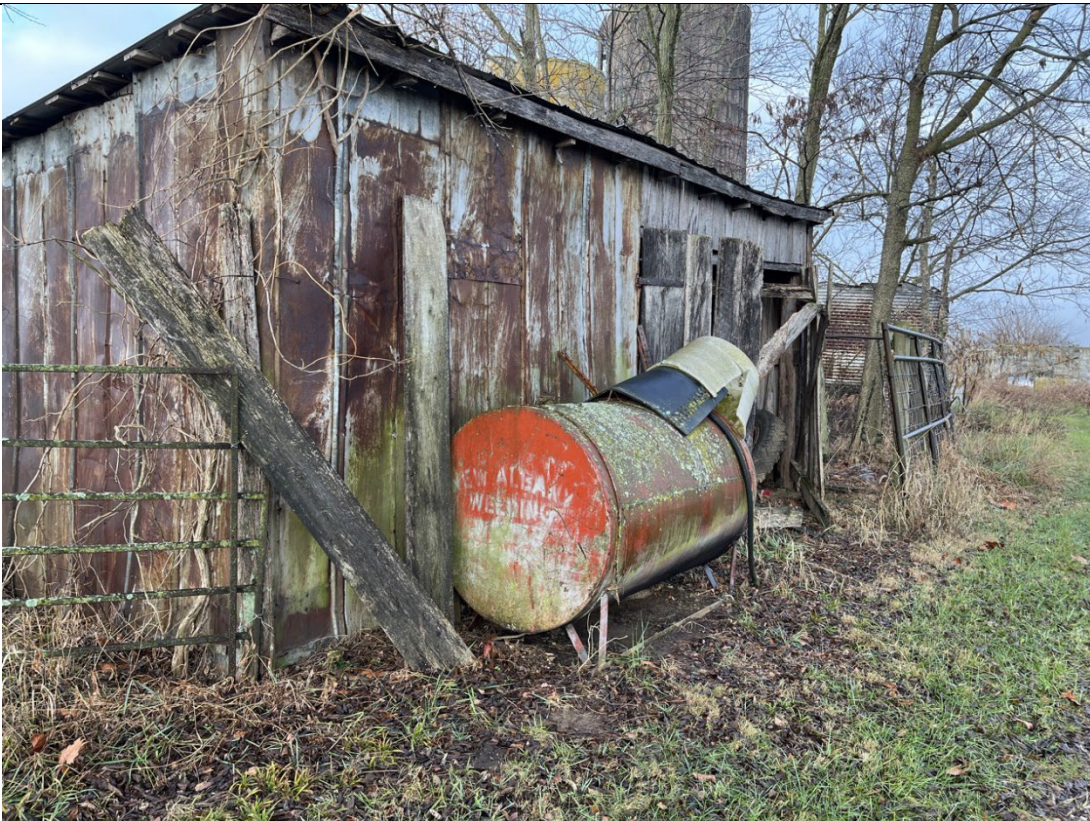
Photograph: 38 | View of barn with AST along Lebanon Rd.
