| EASTERN KENTUCKY POWER COOPERATIVE (EKPC) |
| J.S. COOPER GENERATING STATION |
| JOB NO. 43-24-0331a |

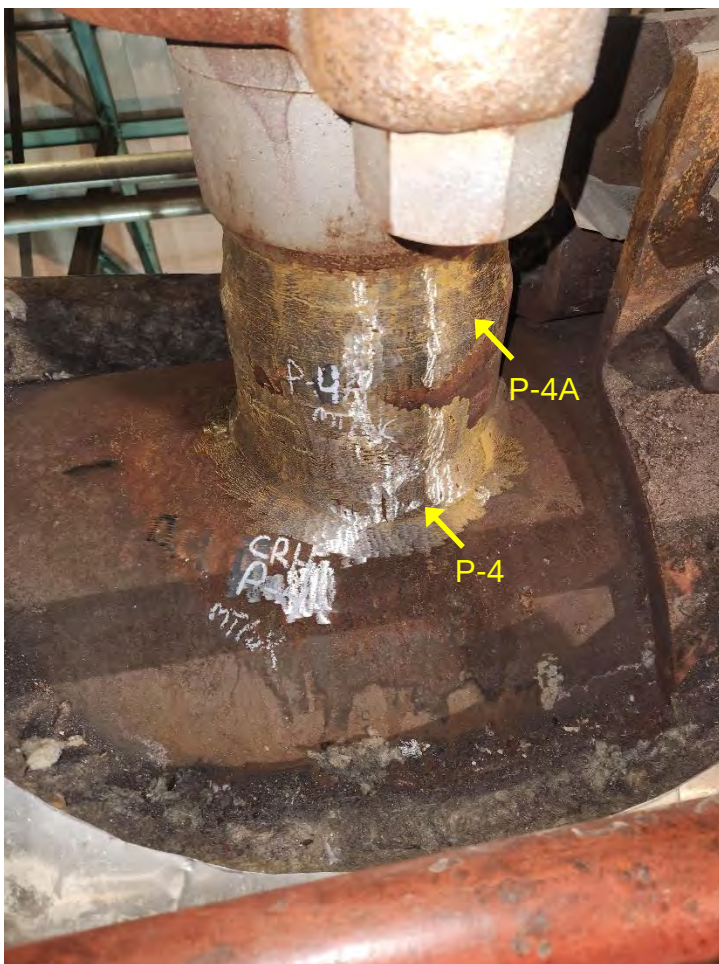
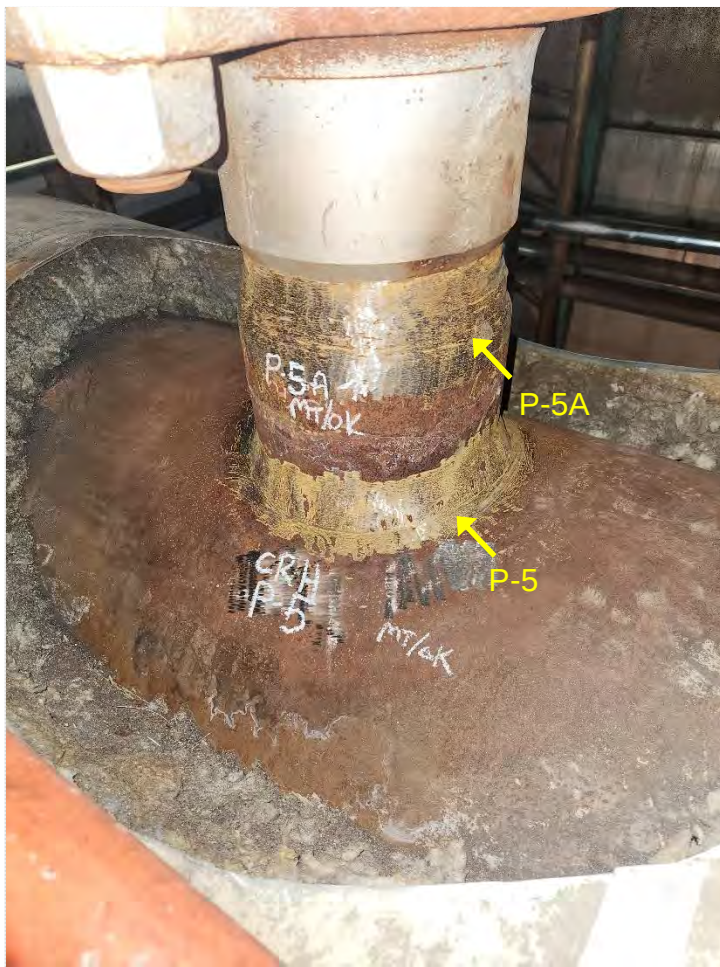
Fig. 34.

Photographs of the inspection locations on the Cold Reheat piping system.

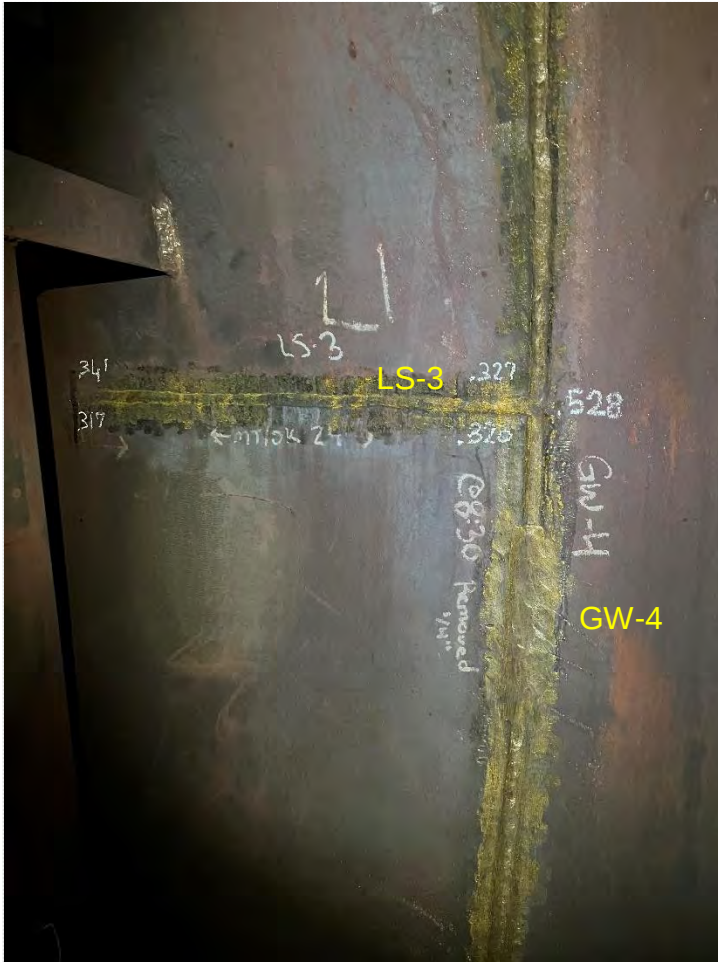
Fig. 42.

Photographs of the inspection locations on the deaerator heater.

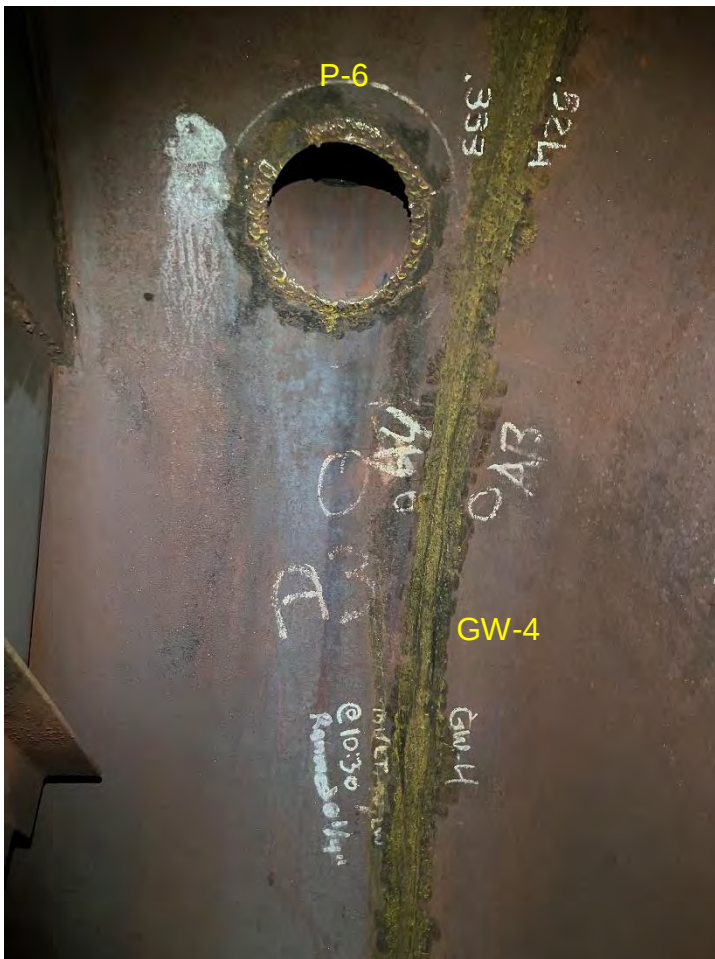
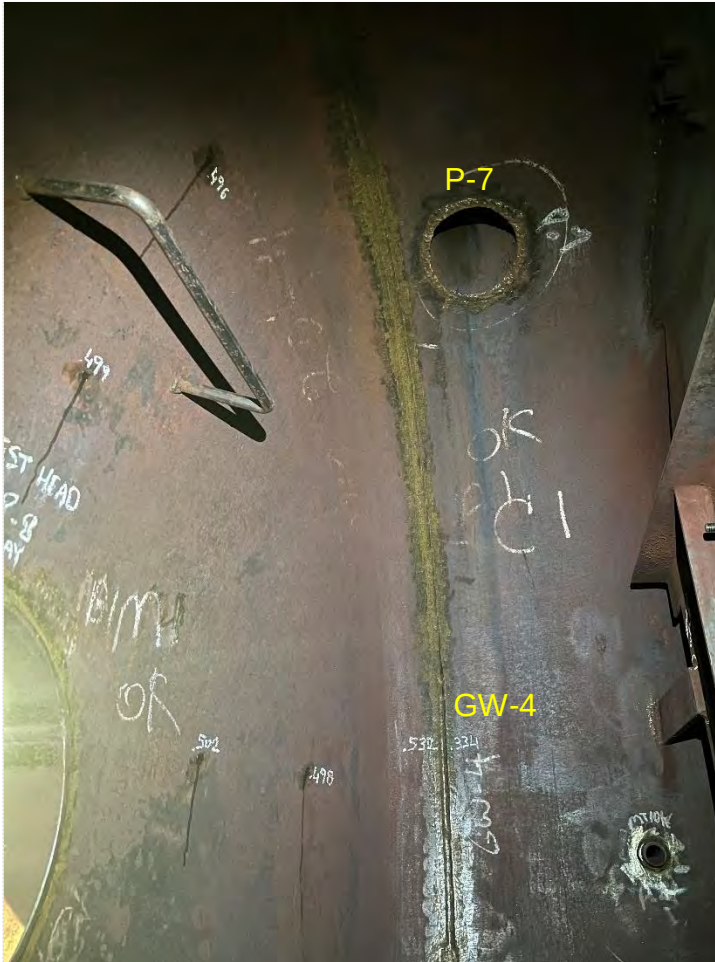
Fig. 43.

Photographs of the inspection locations on the deaerator heater.

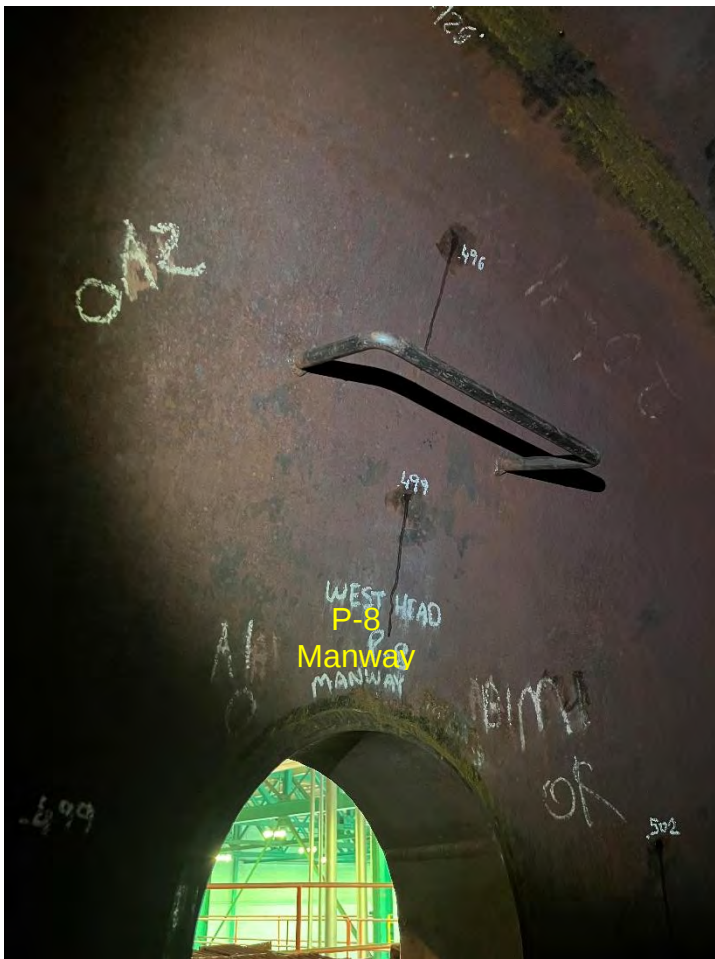
Fig. 44.

Photographs of the inspection locations on the deaerator heater.

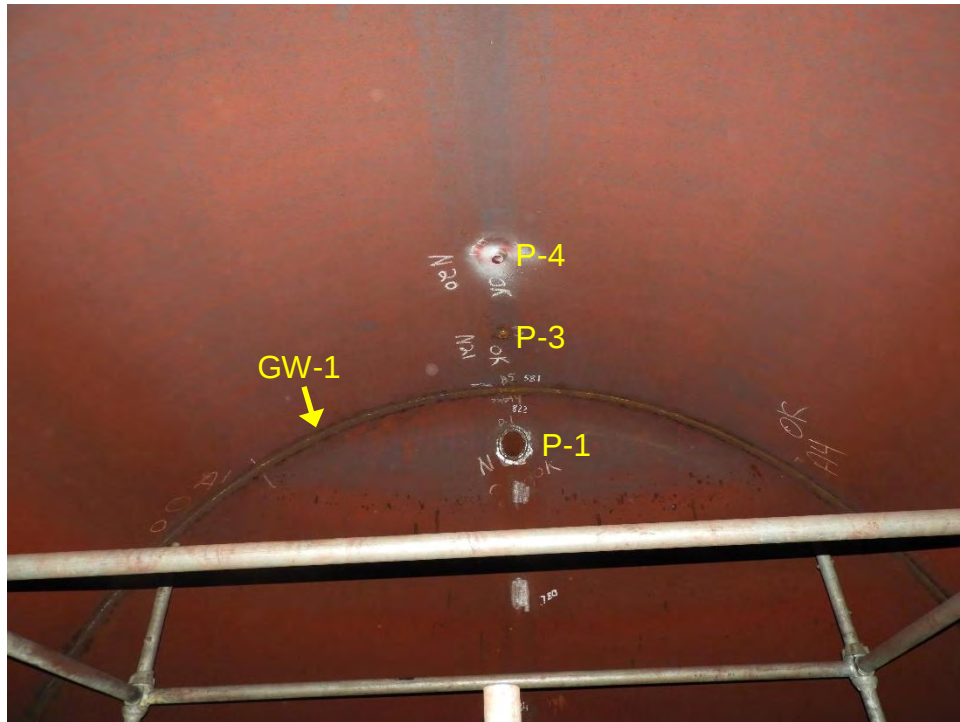
Fig. 53. Photographs of the inspection locations on the deaerator storage tank.

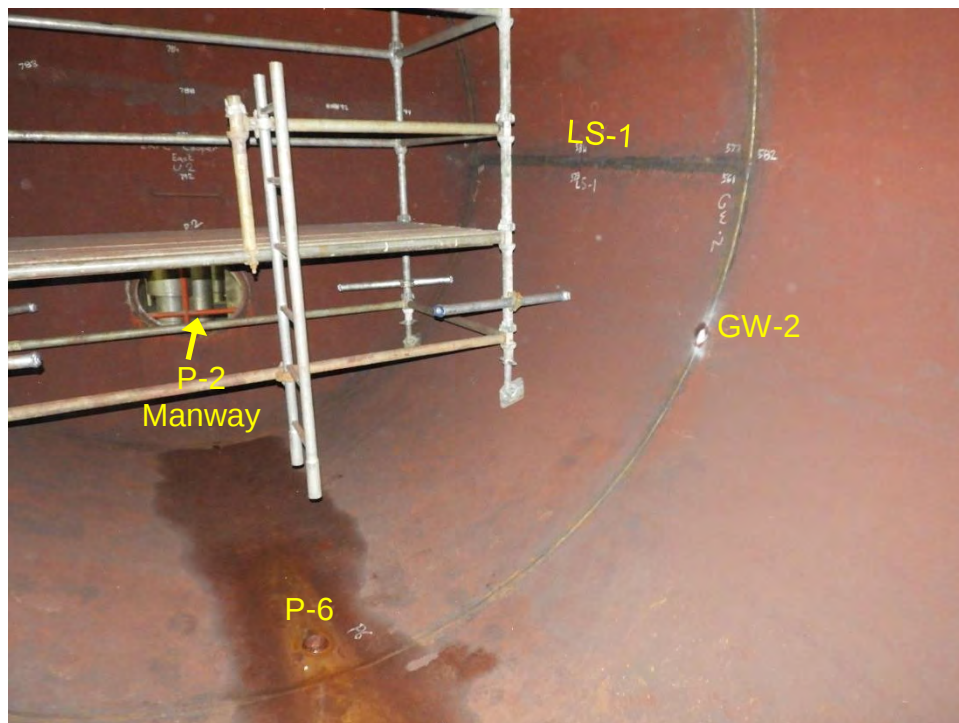
Fig. 54. Photographs of the inspection locations on the deaerator storage tank.

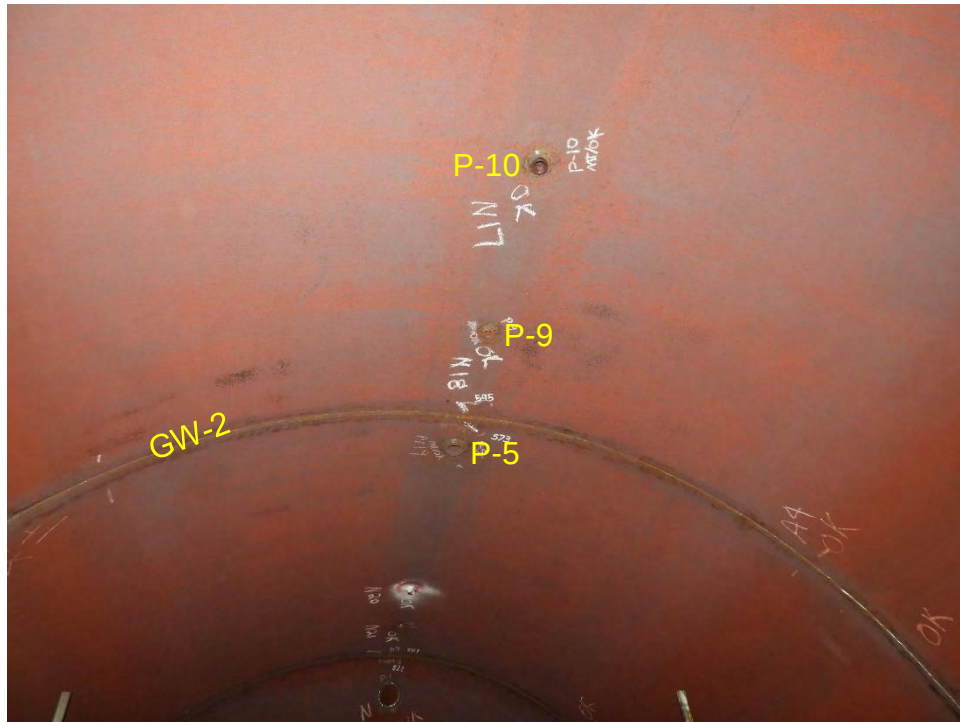
Fig. 55. Photographs of the inspection locations on the deaerator storage tank.

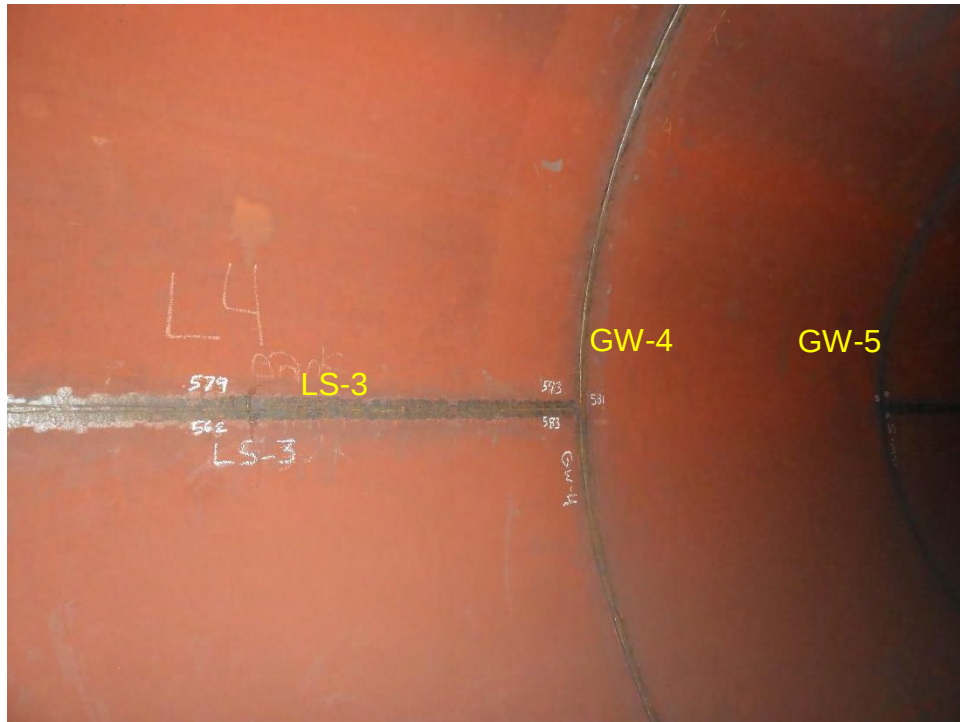
Fig. 57. Photographs of the inspection locations on the deaerator storage tank.

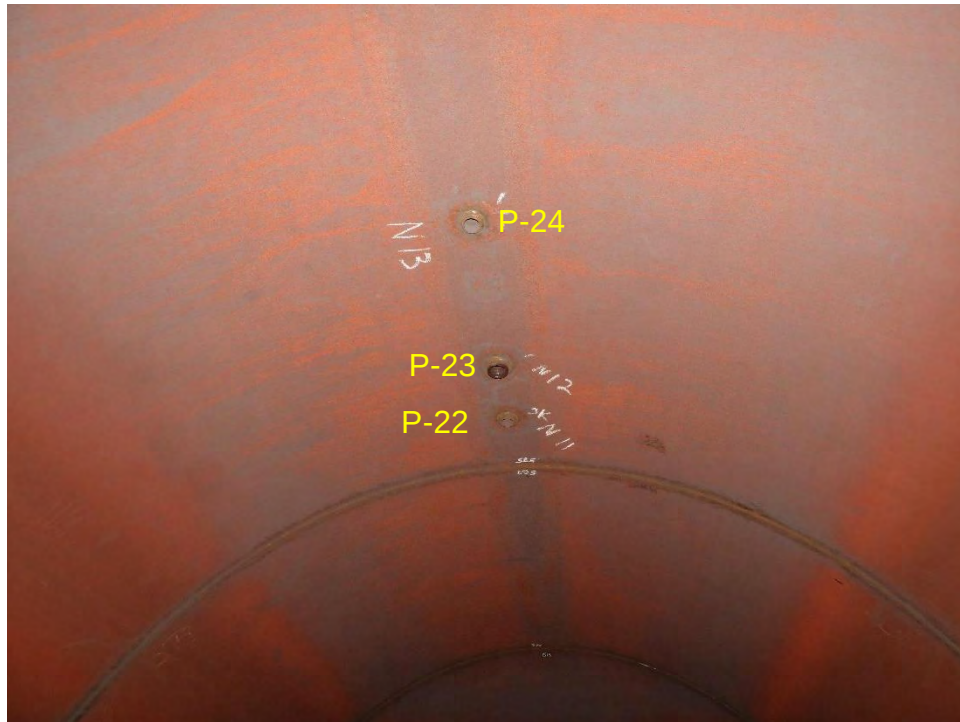
Fig. 59. Photographs of the inspection locations on the deaerator storage tank.

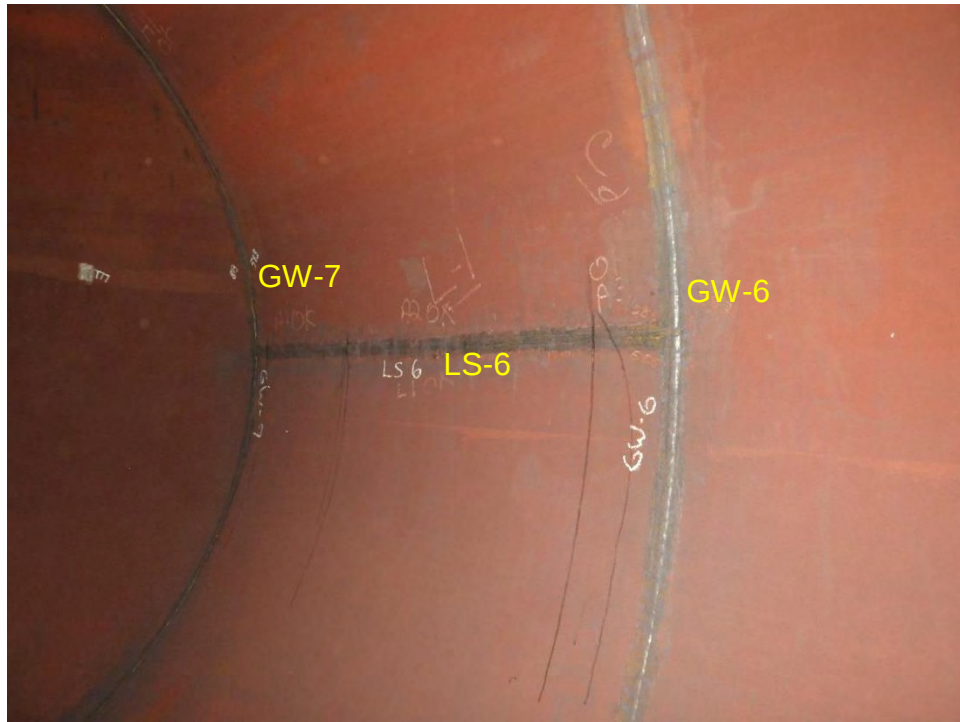
Fig. 60. Photographs of the inspection locations on the deaerator storage tank.
