COMMONWEALTH OF KENTUCKY
BEFORE THE PUBLIC SERVICE COMMISSION

DUKE ENERGY KENTUCKY, INC.)	
_____)	CASE NO.
)	2010-00248
ALLEGED FAILURE TO COMPLY WITH)	
KRS 278.042)

O R D E R

Incident Location ~ Showplace Landscaping, Crittenden, Kentucky
Report Date: March 24, 2010
Incident Date: July 27, 2009
PSC Investigator: Jeff Moore
Utility: Duke Energy Kentucky
Injured: Kenneth Tyler Cummins

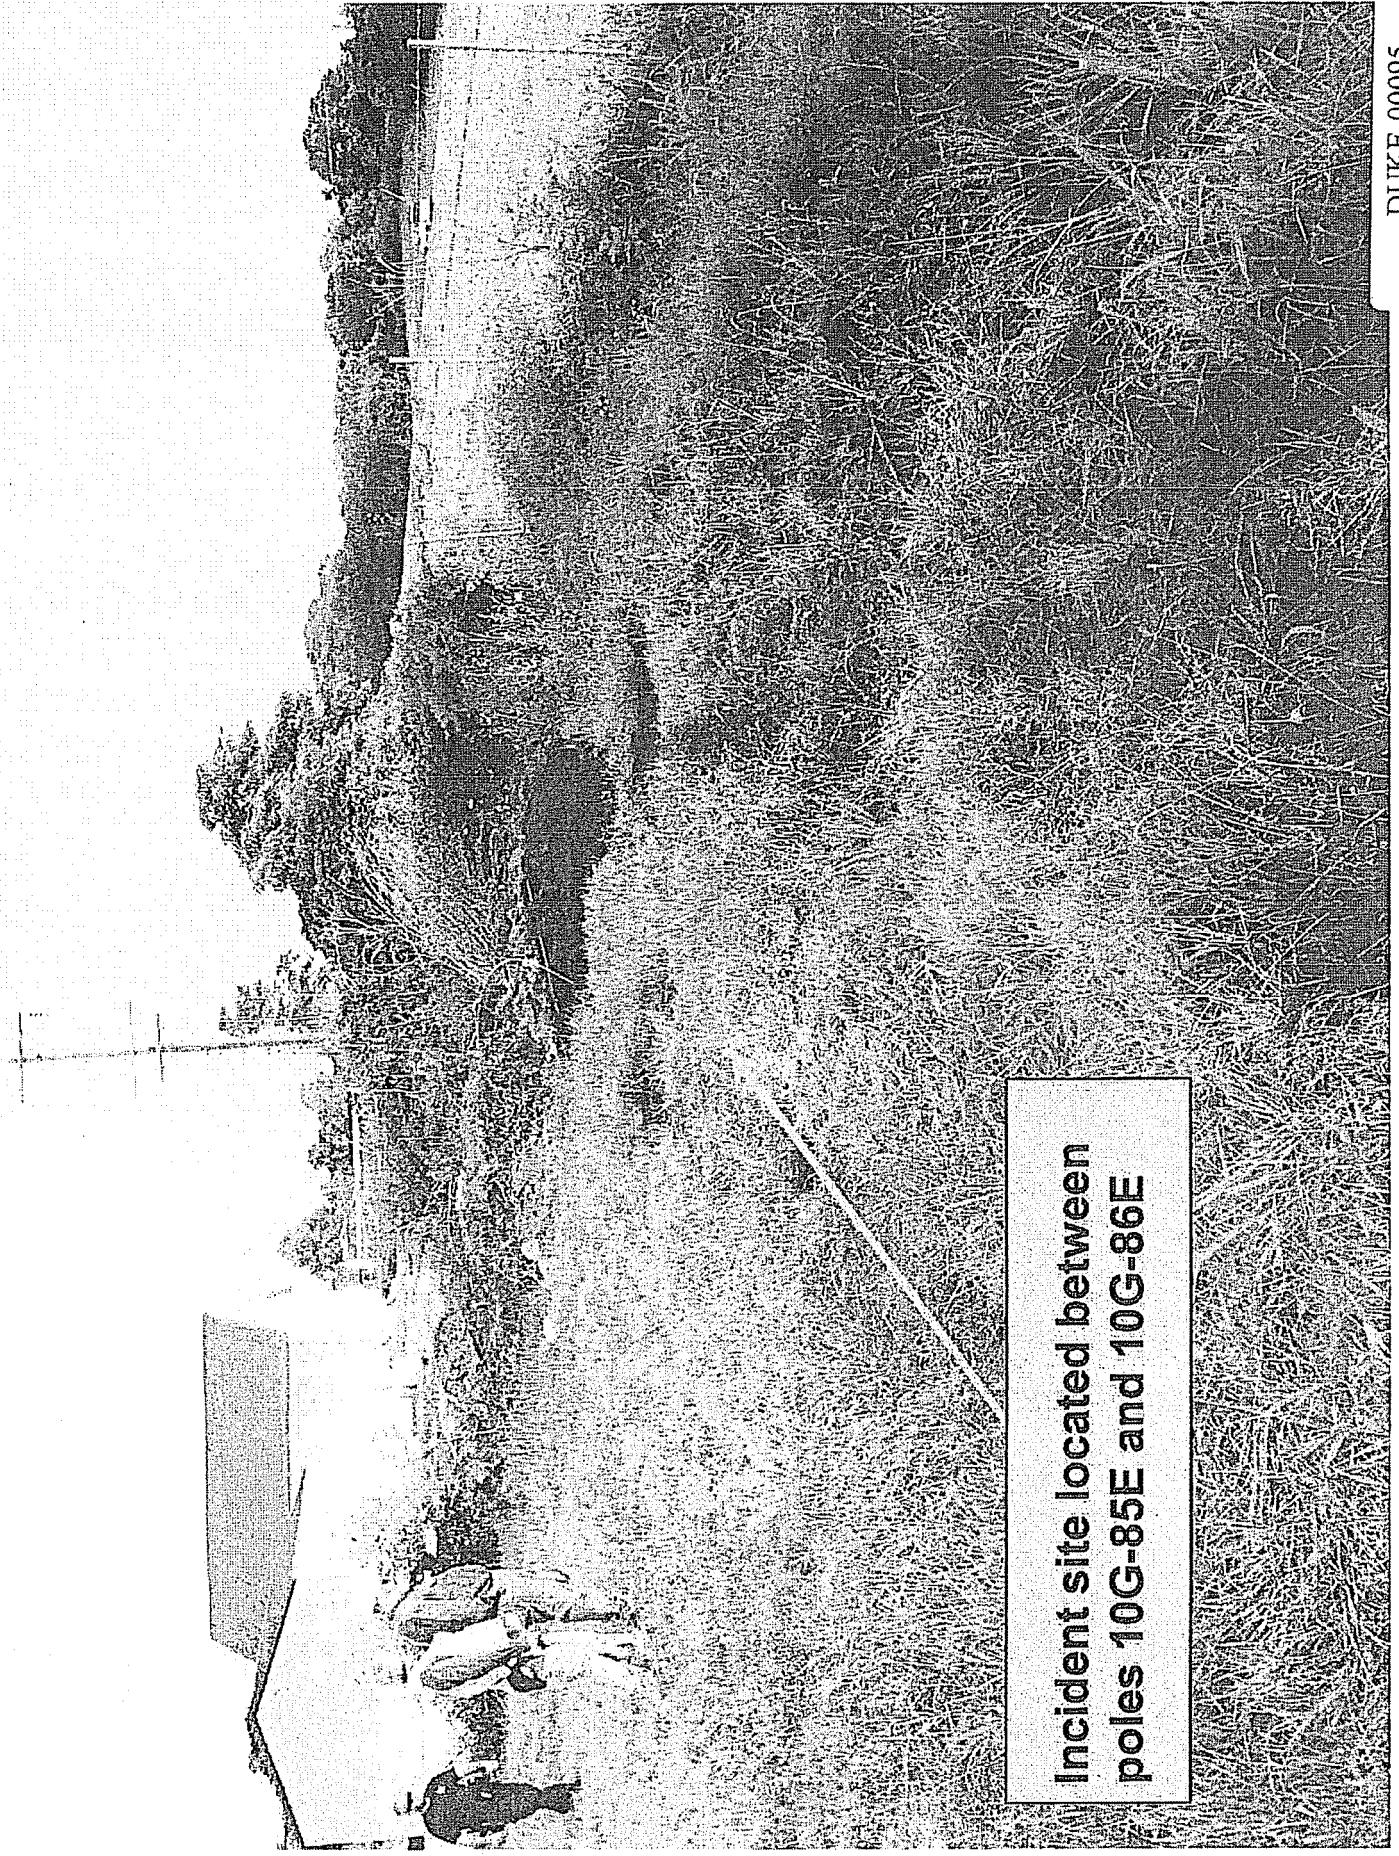
DUKE-00095
CONFIDENTIAL

Incident site located between poles 10G-85E and 10G-86E

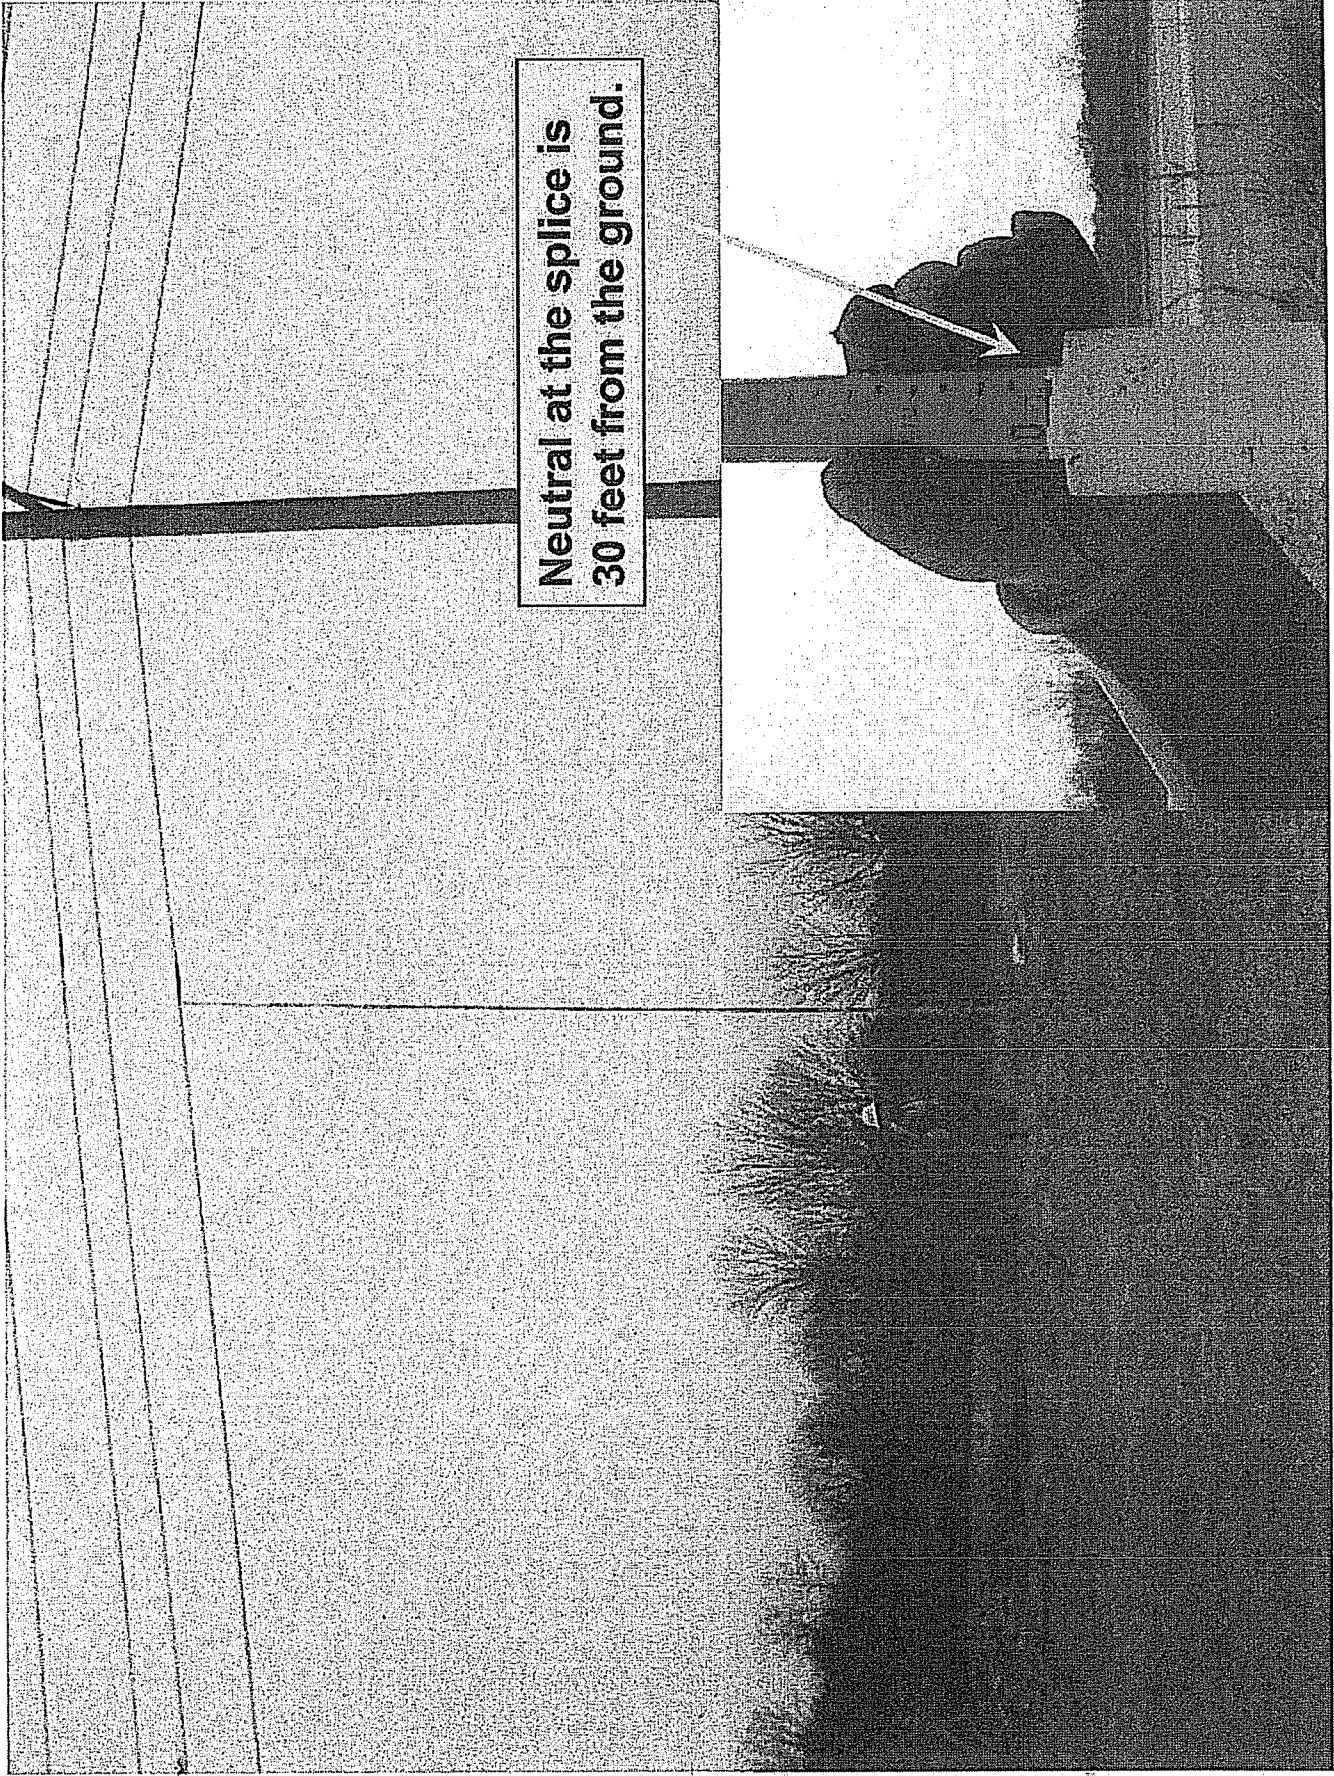
DUKE -00108
CONFIDENTIAL

**Neutral at the splice is
30 feet from the ground.**
